Category: 8 – Best Building Project – GC (Under \$10M)

Contractor: Adolfson & Peterson Construction

Project Name: Boulder Valley School District Mapleton School Historic Restoration: Mapleton Early Childhood Center

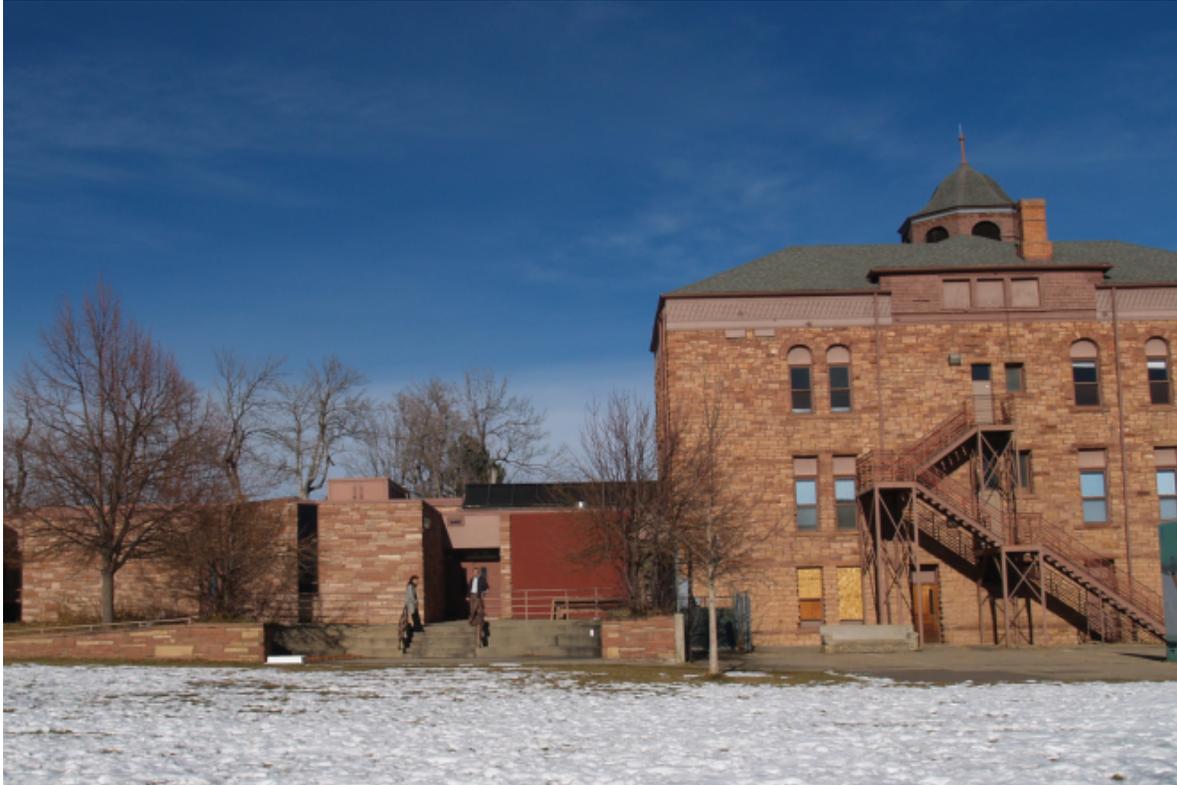
BEFORE: A&P begins the revitalization project on the historic Mapleton School, an iconic neighborhood landmark, that suffered nearly a decade of neglect before work began. Notice the boarded-up windows and unwelcoming atmosphere.

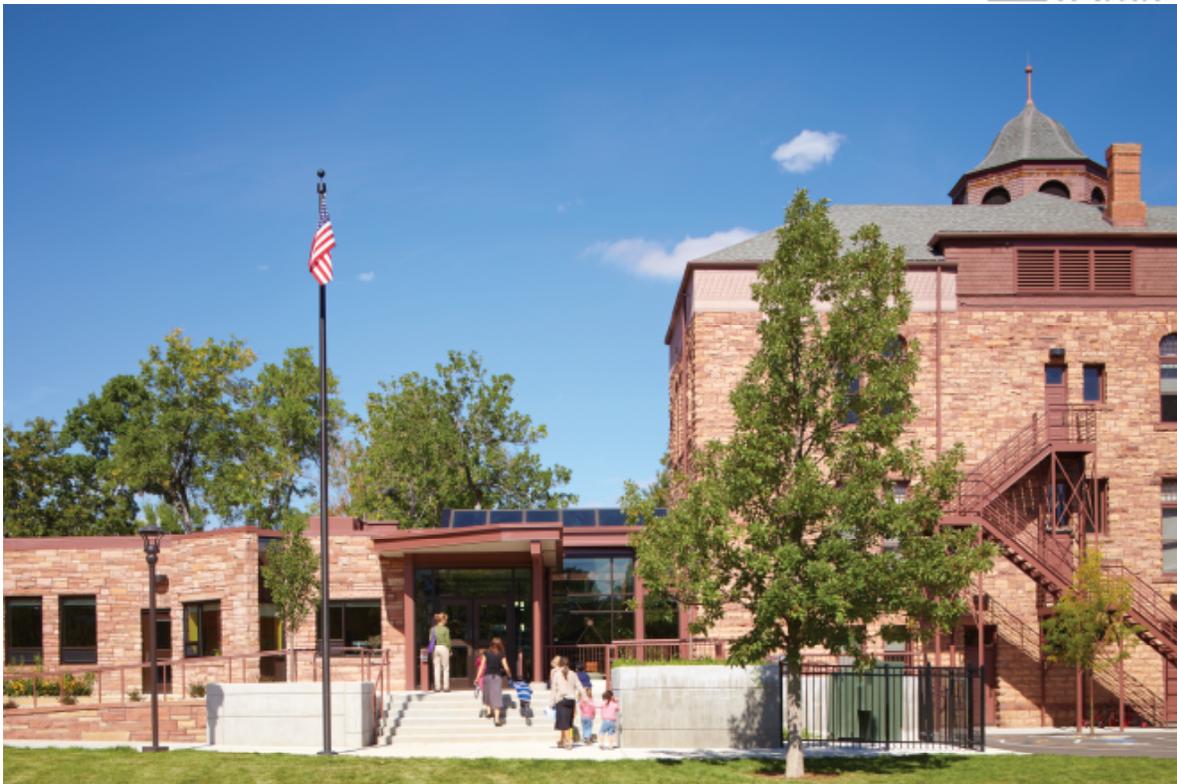
AFTER: The project revitalization created an entirely new ambiance for the school. The school's new entrance was moved to the back of the building, featuring beautiful landscaping and a safe playground. Most importantly, the new site layout gives students and parents a safely-located courtyard with functional access to walk from the school entrance to the new parking lot.

- Refurbished original historic windows
- The tin ceiling, all woodwork, doors, and casings were designed to match the original versions.
- The school's entrance was moved to the back of the building, giving students and parents a safely-located courtyard

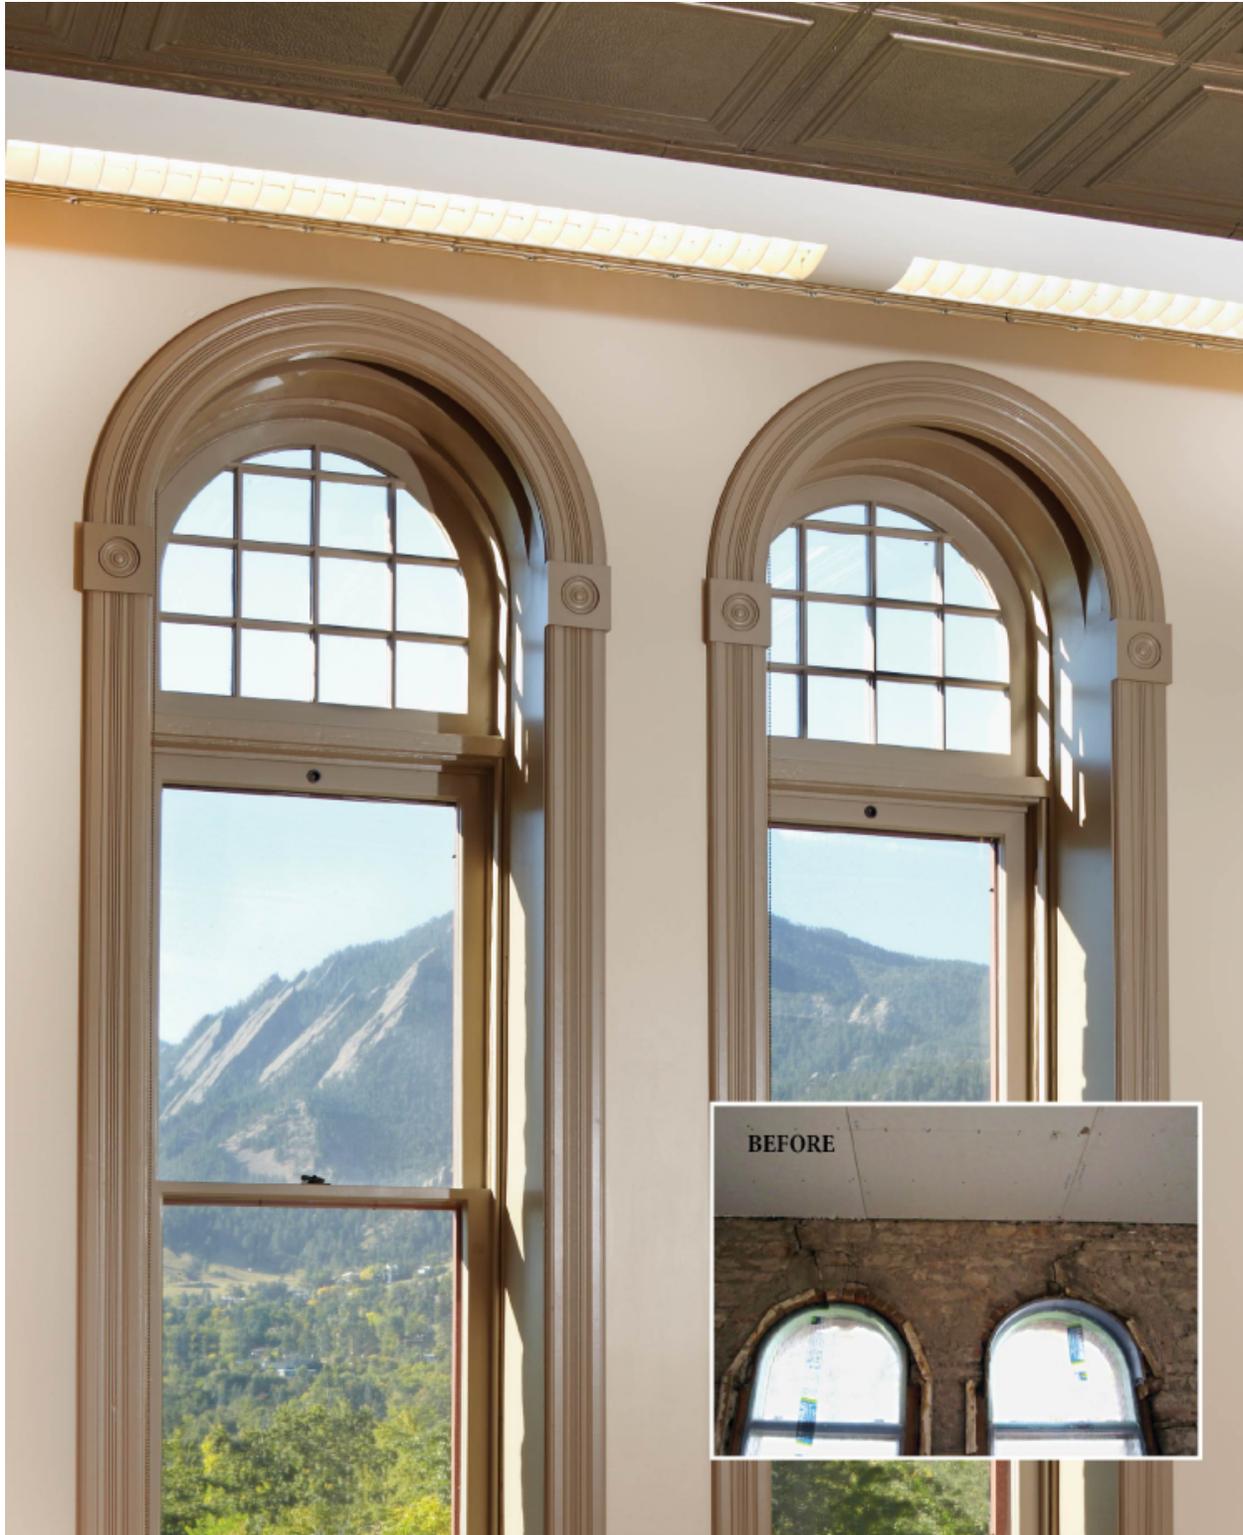
BEFORE AND AFTER: The before photo shows the evidence of structural issues in the existing exterior stone walls. The wall thickness changed from the footings to the top of wall from 2'-6" to 16" respectively so the walls did not stack very well for hydronic rough-in. The window restoration provided a value engineering solution that helped preserve the historic aesthetic of the windows.

The window restoration provided a value engineering solution that helped preserve the historic aesthetic of the windows while increasing energy efficiency and reducing maintenance costs.

The original plans called for new high-efficiency windows in the entire building. However, after working with the historic society, A&P suggested restoring the original 1888 windows. A&P provided mockups and layouts that coordinated jamb extensions, trim moldings, roller shade pockets, sash pulls, cords, and hardware, and improved the design of true divided light muntins at transoms and pocket windows. The windows were removed and taken off site for restoration, and through the architect, A&P coordinated the requirements for fire-rated glazing, insulated glass, and paint to match the original school colors so that the restoration would be historically authentic.

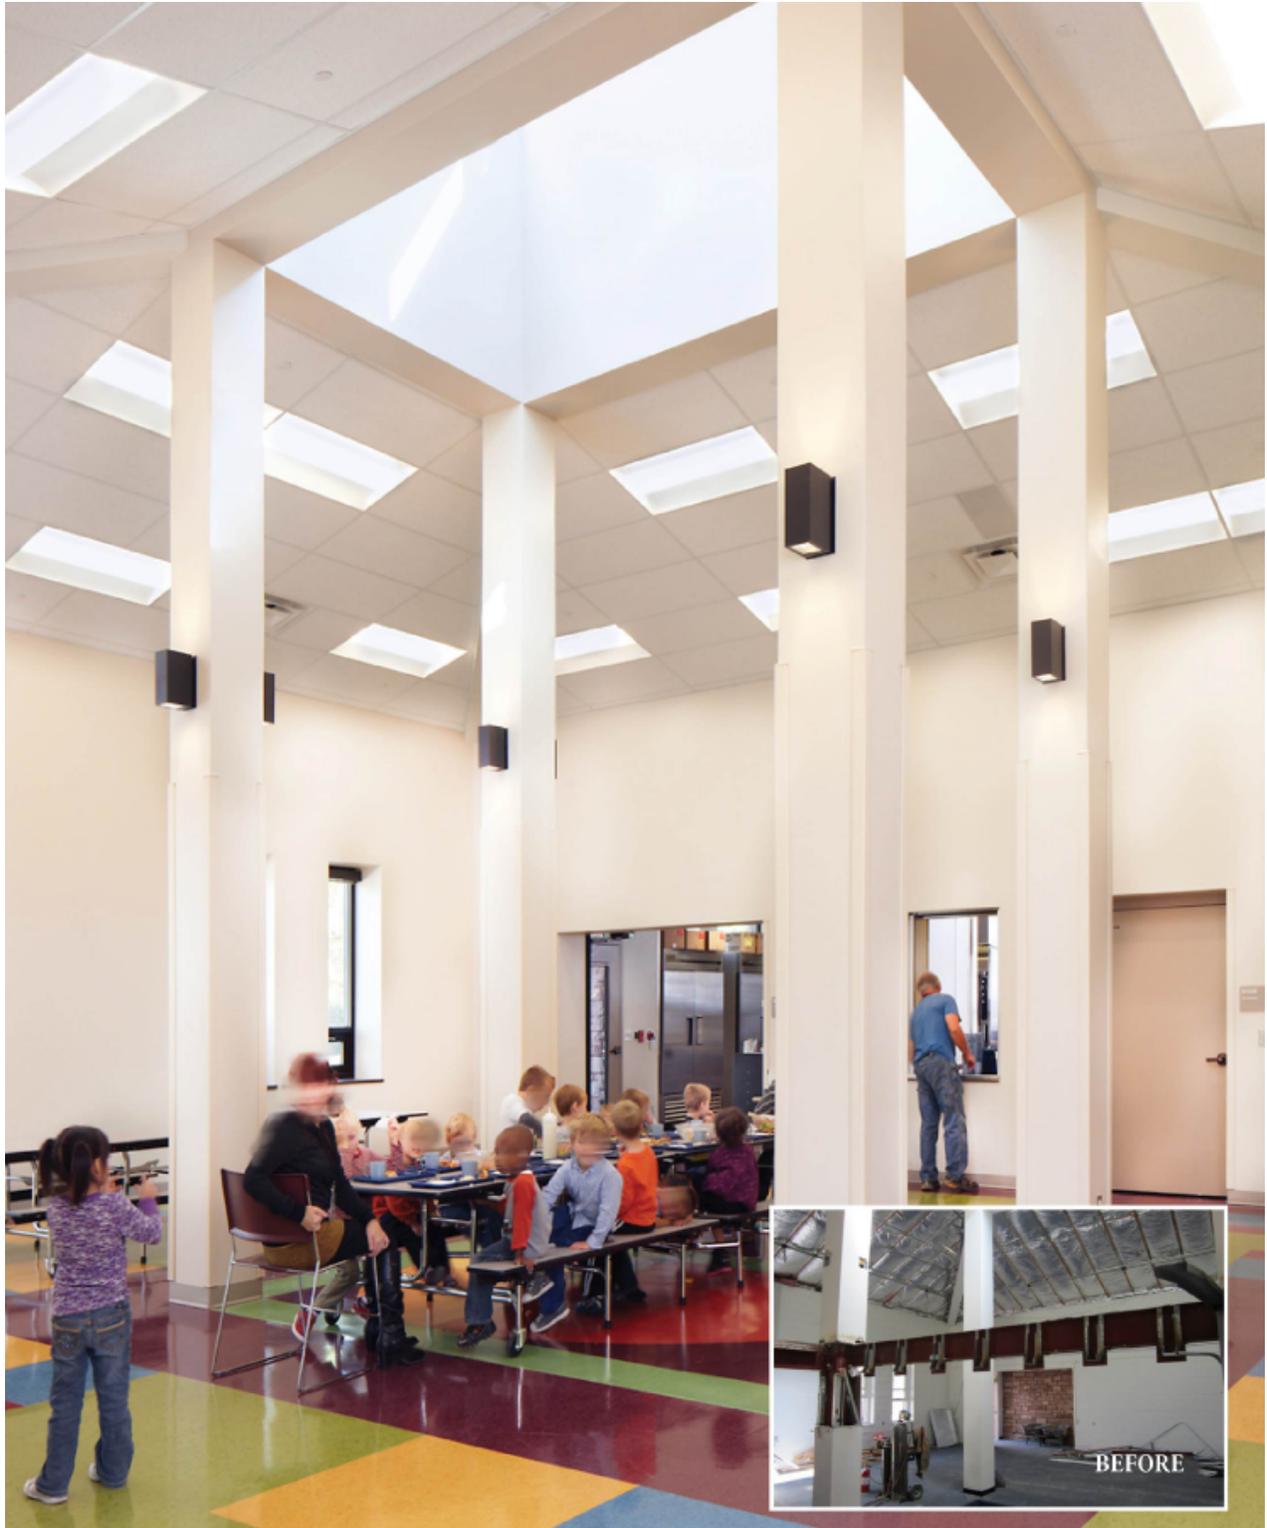
BEFORE and AFTER: The former large library, built in the 1970's, was not a functional space for the school's ECC curriculum. Therefore, the space was renovated into a much-needed cafeteria and multi-purpose space. The new functional space features a vibrant colored floor and high ceilings with clerestory windows, encouraging creativity.

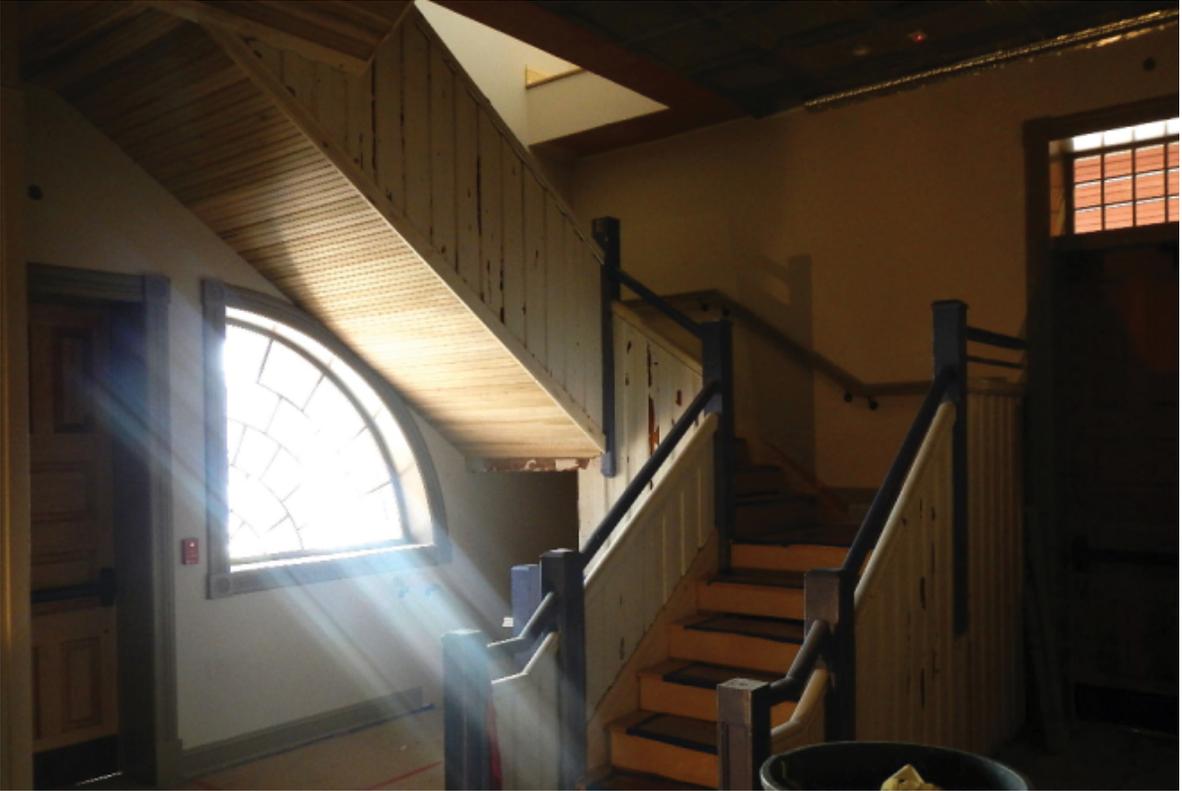
BEFORE: The existing staircase in the historic school was not only out of code but very drab and dark.

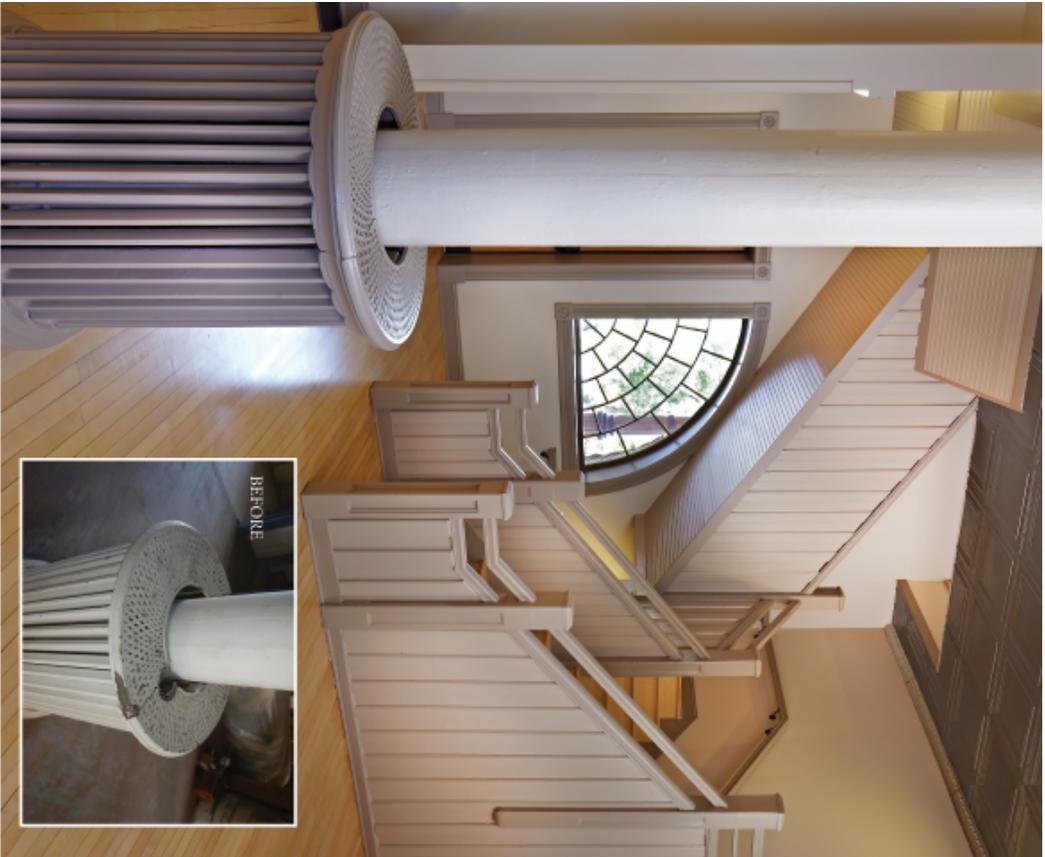
The historic main entry of the building became the focal point again with its ornamental staircase and refurbished radiator. The staircase was brought to life again with its detailed moldings and new stair treads and risers to blend with the classic maple floors. All of the kept handrail details were coordinated with the State Inspections to meet safety code. Although the radiator is not in operation any longer, it brings aesthetic and historic value to the space. Original features were replicated to match the replaced pieces including the unique fin ceilings and crown moldings.

- A new, safe, playground was installed and a local piece of art "Slick the Pig" was rehabbed.
- Original wood floors installed in 1922 were refurbished and the historic stairway was rehabbed.

- The existing school bell was modified with a rope and pulley to make the bell functional.
- A round radiator was restored for aesthetic value.

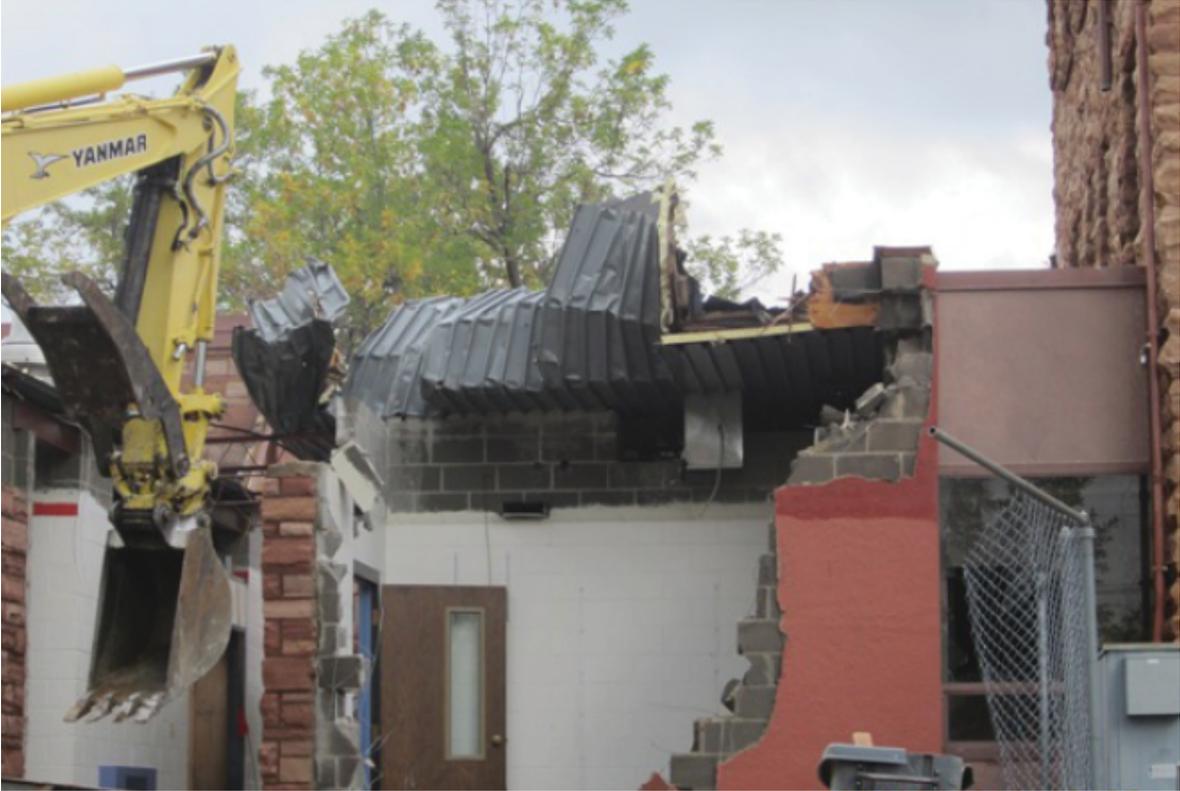
A new cohesive design was created to link the newly constructed building spaces with the historic building. Highly coordinated demolition took place to remove the former entrance without damaging any of the historical building.

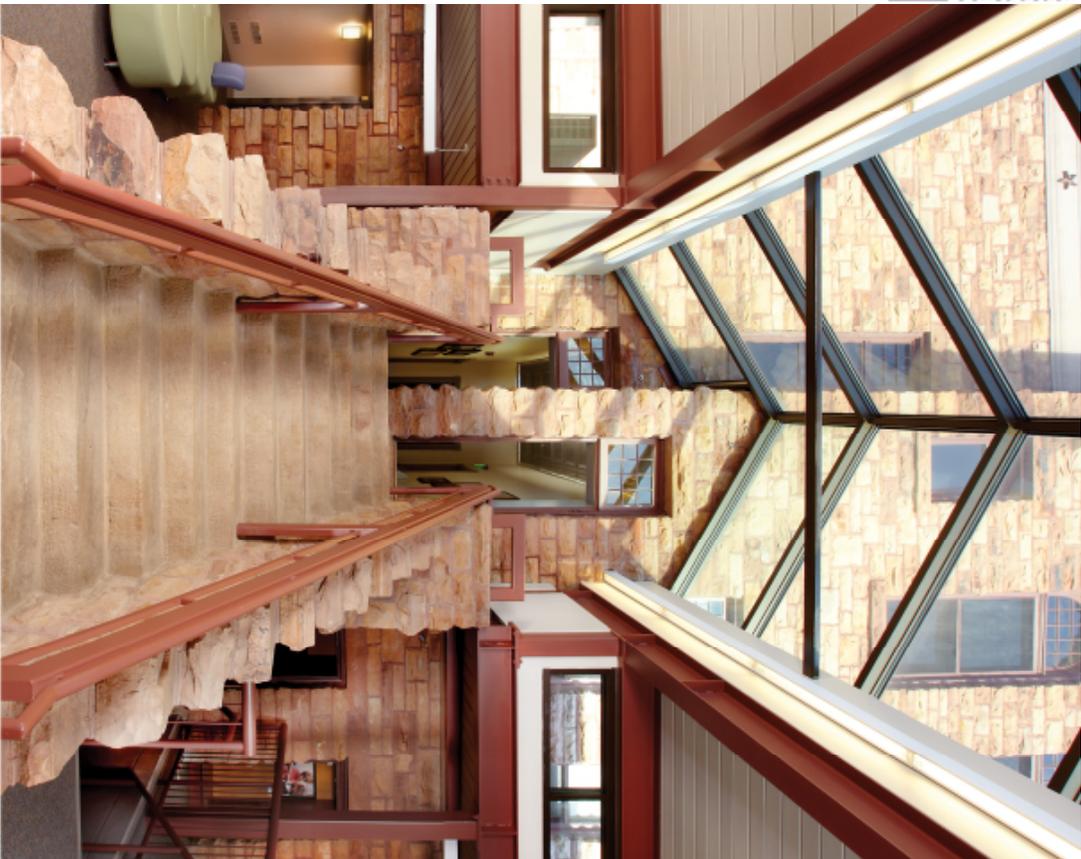
The redesigned "link" provides both a functional use of space as well as a beautiful aesthetic setting for entering into the building. Evidence that the construction team excelled in terms of quality and craftsmanship is understood by seeing the seamless integration from one building to the next.

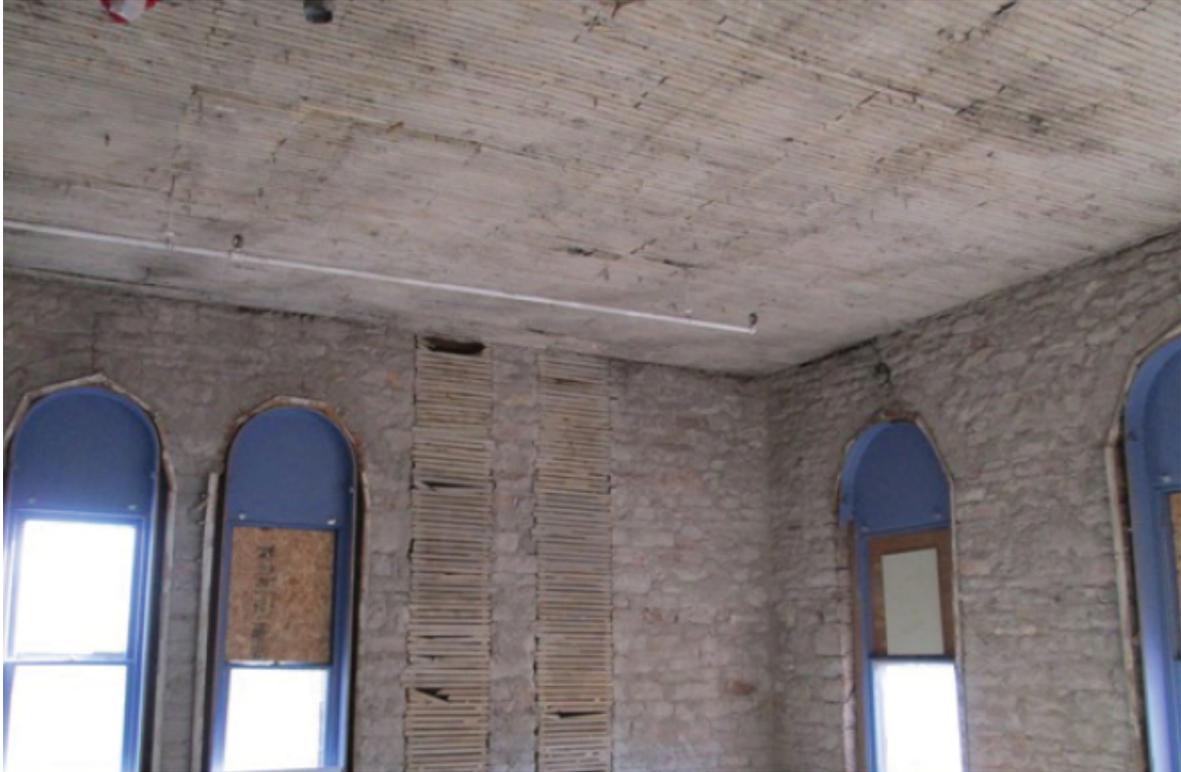
BEFORE: The 1889-built building sat vacant with structures in shambles. Each wall was a different width because of different materials used throughout the eras. In addition, none of the original walls could accommodate modern-day insulation or MEP. Each wall had to be opened, redesigned, and replaced.

- All the historical walls were not designed to meet contemporary MEP standards
- The attic was not designed for the new boiler equipment and new heat recovery ventilation that was needed. Layout and material selection was crucial to being compatible with the attic space.

- Dust control: Dust control with asbestos and lead-paint surfaces was a top concern that was addressed in our safety plan.
- EPA guidelines for hazardous material remediation: This meant stripping down to the exterior stones walls section by section; removing the old lath wall support system; shoring bearing walls with additional structural support; and then applying spray foam insulation with metal studs and drywall. The insulation was a dramatic improvement in terms of the former building's thermal performance; bringing the building up to about an R-19 value, while also providing an acoustical buffer between excited young voices.

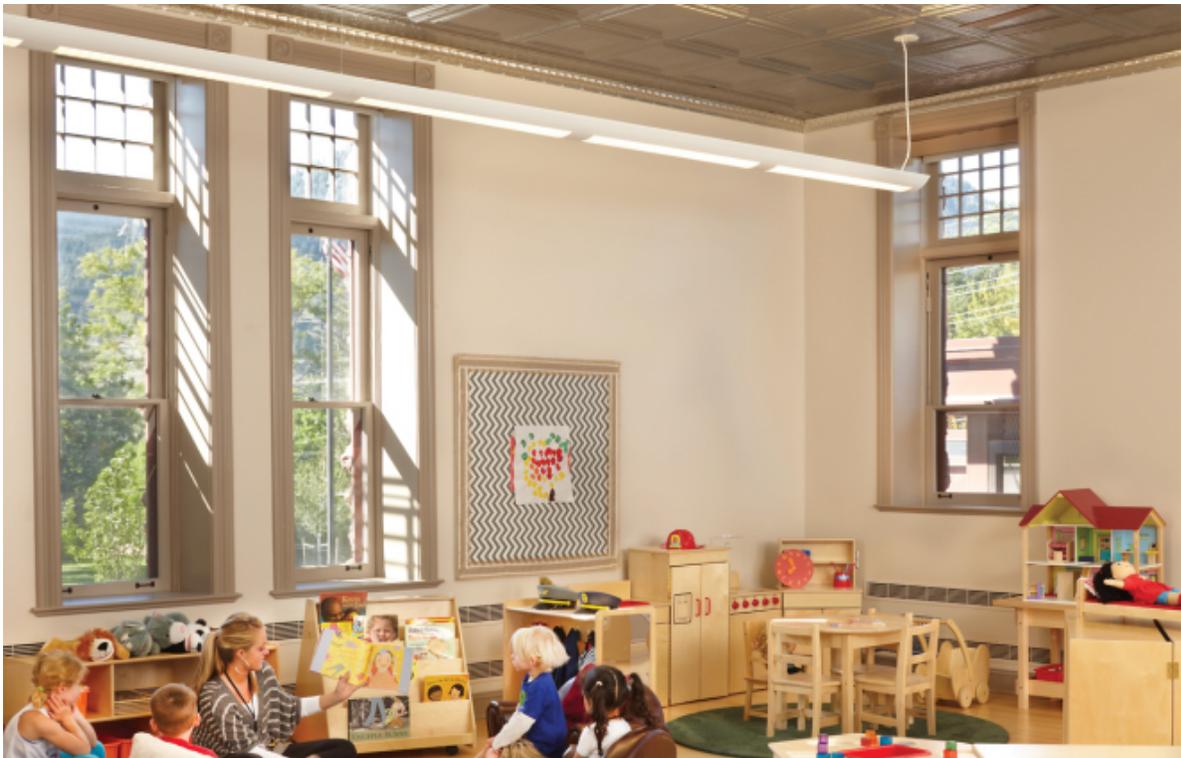
AFTER: The seamlessly-integrated radiators in the walls, refurbished tin-ceilings, original maple floors and restored historical windows all create a modern learning environment that is now warm, welcoming and functional. Unseen insulation provides the needed thermal performance while also providing an insulation acoustical buffer between excited young voices.

- Integrating technology: The construction team installed innovative built-in radiators directly into the walls, which met a functional need and coordinated well with the historic interior quality. The clean lines and smooth surface blends seamlessly with the other features of the space.
