There's no doubt arena projects are challenging; the sheer size and complexity of modern arenas guarantee that. The University of Wyoming Arena Auditorium renovation, however, posed more obstacles than most. From unknown conditions behind and below the 30+-year-old concrete walls, floor, and tread risers, to unforeseen weather circumstances, this project stands out from the crowd.

Originally built in 1982, this NCAA Division 1 arena is home to the UW Cowboys and Cowgirls basketball teams. Despite the 200,000 SF area, the floor space was inadequate for an effective practice area (Photo 1). The University also wanted to enhance the customer experience for the incredibly loyal fans. Rather than build a new facility, the University chose to increase the playable floor space and upgrade the fan experience within the existing footprint.

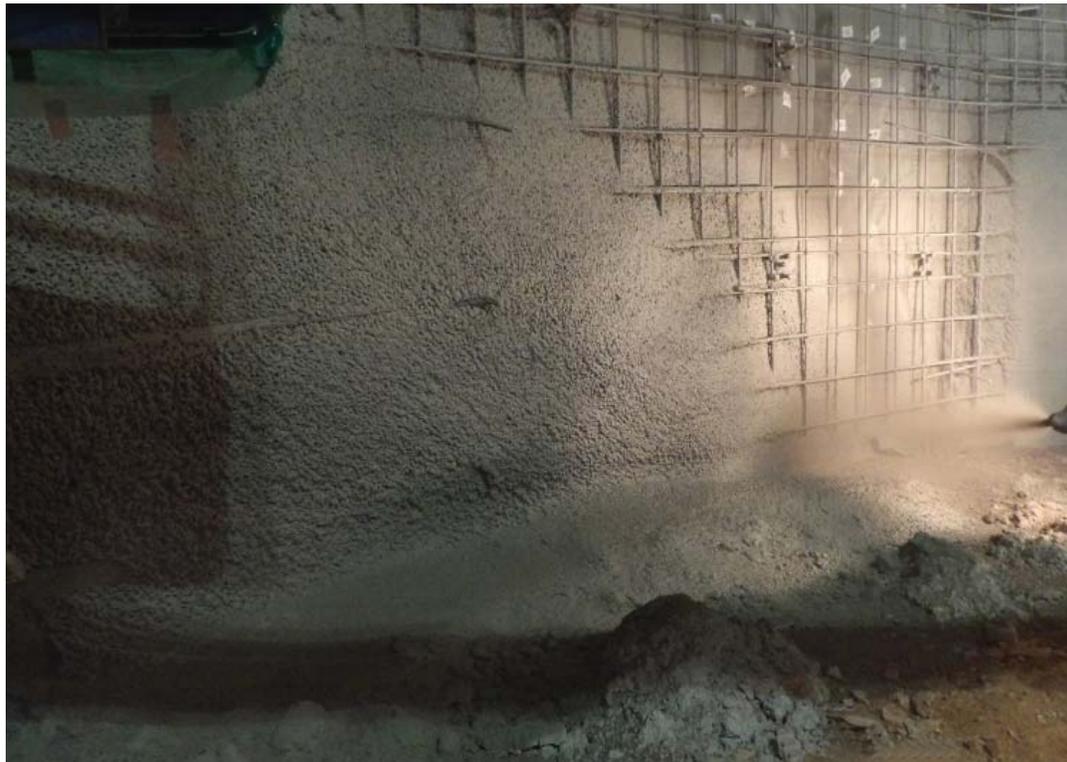
02-Haselden-UW Arena

Haselden's task was to demo approximately 7,000 seats—removing 12 rows (about 36') of cast-in-place tiered concrete—rebuild the walls where we would install telescoping seating, and rebuild the floor. Our first challenge arose during the demolition: instead of finding only soil behind the concrete, we discovered “gravel pockets.” Because the original concrete was poured on a slope, the gravel pockets would slough off, effectively draining the support for the concrete that was to remain above the demolition levels. Through a combination of grout injection, shotcrete application, and overhead grouting, our team was able to stabilize the gravel pockets and allow the soil nail and shotcrete wall application to continue (Photo 2).

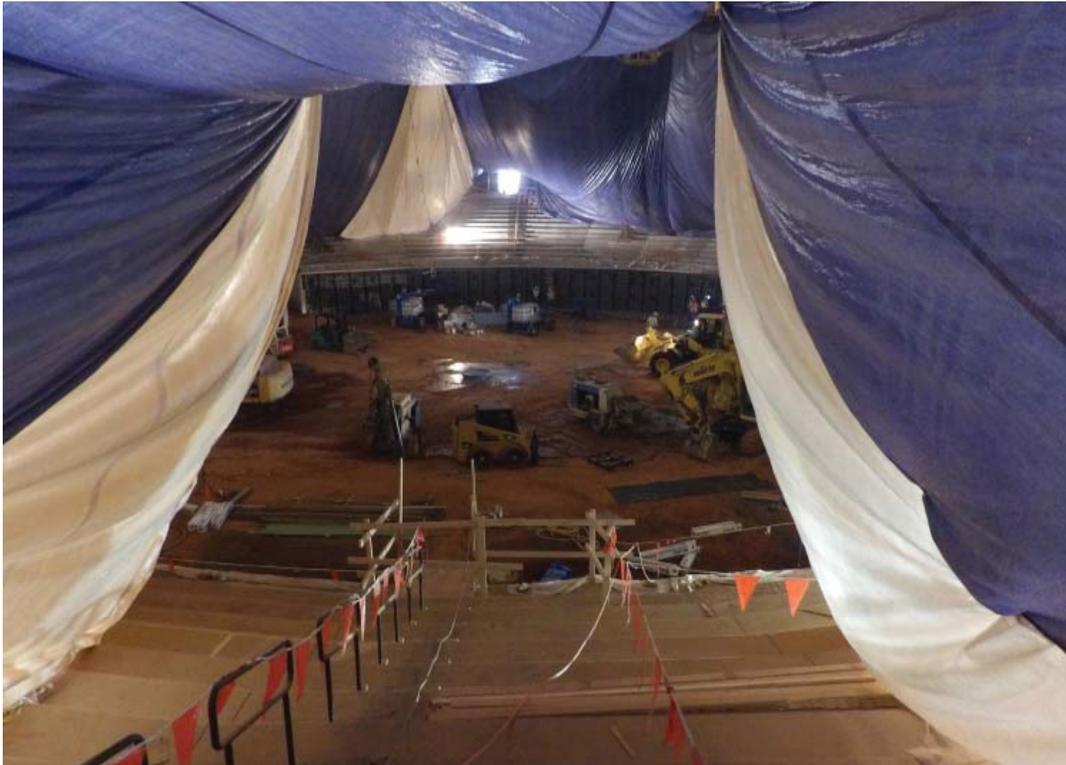
03-Haselden-UW Arena

Because the fully functioning administration building was directly adjacent to the arena, dust and noise control were major considerations. Our solution: tent the entire demo area (Photo 3). This “circus tent” style containment method proved highly effective at reducing noise and dust in the immediate vicinity. To properly ventilate the tented space, we took an unusual approach. On two opposite sides of the arena, we created “tunnels” with fans that provided 110,000 CFM of ventilation. These tunnels led out the doors of the arena and allowed for effective ventilation of equipment exhaust to provide the crew with a safe work environment. The fresh air came in through the truck ramp. The tunnels were created with garage tents (portable carports) that were connected together. They were inexpensive, effective (Haselden hired an industrial hygienist to perform a study guaranteeing the proper ventilation of the site), and, after the project was completed, were repurposed to the University and some laborers for use on campus or at home. Another example of reusing materials occurred during the demolition/excavation. The 3,500 cubic yards of dirt we removed was hauled offsite to the UW stockpile, and we cleared 1,200 tons of concrete which was recycled (Photo 4).

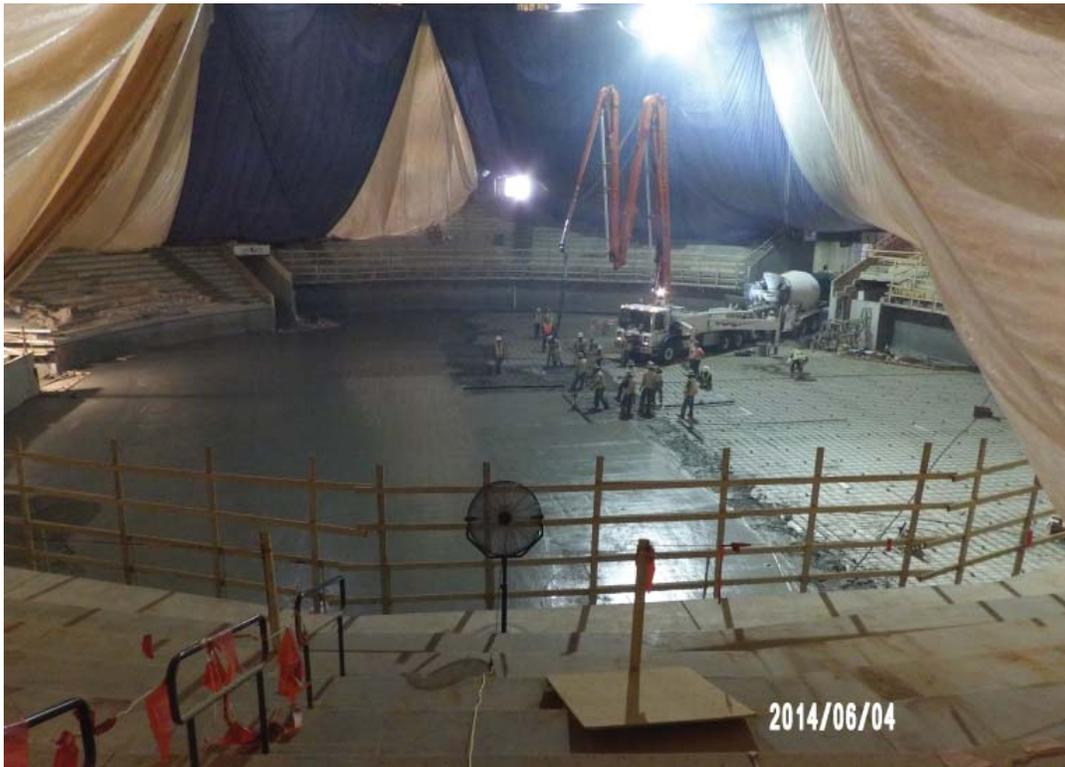
05-Haselden-UW Arena

After the walls were complete, the next step in the process was to pour the foundation floor. Because the wood floor that was to top the foundation would be laid below the water table, extra precautions for moisture prevention were necessary. An additional sump pump was added to support the expanded floor space. Water proofing membrane went behind the shotcrete wall, then tied into the water proofing membrane placed under the concrete floor pour. Most importantly, Haselden decided to do one continuous pour, thus eliminating construction joints in the concrete (which are a natural seepage point). Haselden poured the

perfectly flat (a necessity due to the wood floor that would top it), 18,000 SF slab (306 yards of concrete) in 11 hours (Photo 5).

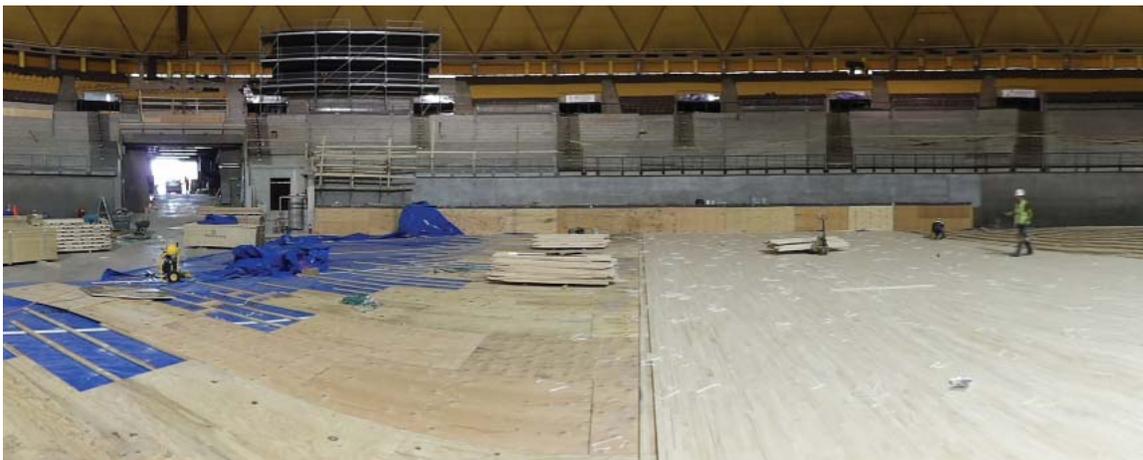
06-Haselden-UW Arena

The next challenge involved the wood floor and its effect on the schedule (Photo 6). The University basketball season ended in mid-March and the arena needed to be ready for use by the 7th of October. While the first game isn't until the first week in November, both basketball teams are allowed 30 days of practice before the first game. If construction wasn't complete, it would put the teams at a disadvantage for the entire season. Given that the facility has been nicknamed the "Dome of Doom" due to the Cowboys winning 74% of their games, this was not an ideal situation. Our first step to overcome the timing issue was finding an additive made by Concure Systems which allowed us to install the wood flooring 7 days after the pour (as opposed to the normal 30 days). Before the pour, we obtained a warranty from Concure ensuring the performance of both the slab and the wood floor, protecting the owner and the construction team.

During the installation of the floor, another unforeseen circumstance occurred. We allowed time for the wood to be laid out and acclimate in the arena environment. Unfortunately, during this acclimatization, Laramie – normally an arid climate – received record rainfall. This caused the wood to swell with 7-8% moisture content and the subcontractor refused to install until the moisture content was down to 5.5%. To solve this issue, Haselden tented the entire 18,000 SF basketball floor area and installed dehumidifiers for two weeks. Because this unanticipated circumstance greatly impacted the schedule, Haselden could only guarantee delivery by October 17th, leaving the players with only two weeks to practice instead of the 30 days they're entitled to. Additionally, the distinction of being the highest altitude (7,220 feet) NCAA Division I basketball venue in the country has its downfalls, and in this case, impacted the schedule. Spring in Wyoming still brings snow, and there were multiple (7-8) instances when the weather was so bad that all roads to Laramie were closed, meaning workers and supplies couldn't get in. To combat these schedule issues, the Haselden team worked 7 days per week (two shifts per day to get the floor installed!) and were able to turn the facility over on October 6th.
