2015 AGC ACE Awards

Specialty Contractor: Sturgeon Electric Company, Inc.

Project Name: Saint Anthony Hospital North Health Campus

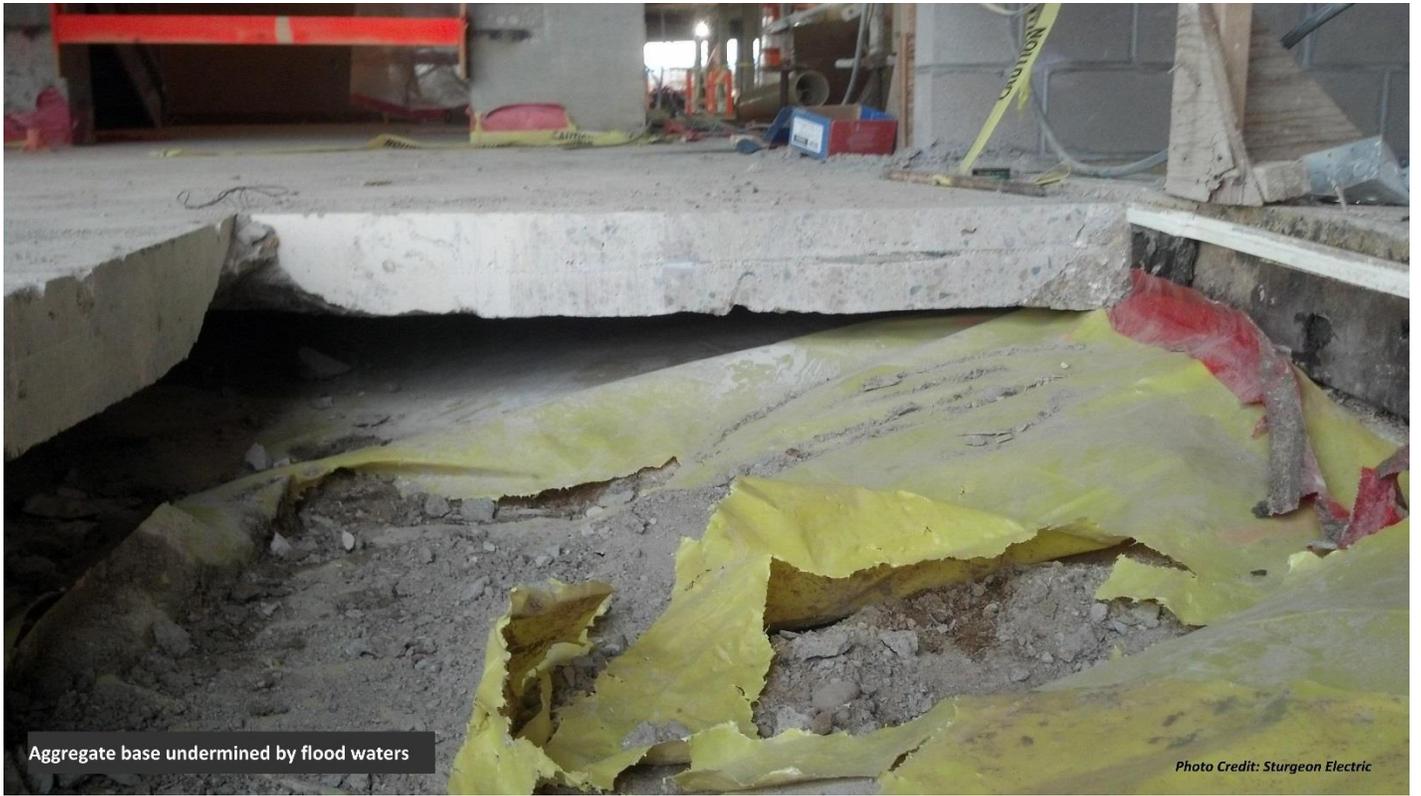
Aggregate base undermined by flood waters

The water runoff swept away huge portions of the aggregate base beneath the 10” thick concrete slab, which was ultimately compromised and sinking. Upon further inspection with Ground Penetrating Radar, the full extent of destruction was revealed; over 17,000 square feet of the concrete slab and underground installations would need to be excavated and reinstalled. This threatened to deny the owner and local community of their new hospital for four to six weeks. However, Sturgeon Electric and project partners would stand unified in a determined effort to fight back and reconcile the schedule.

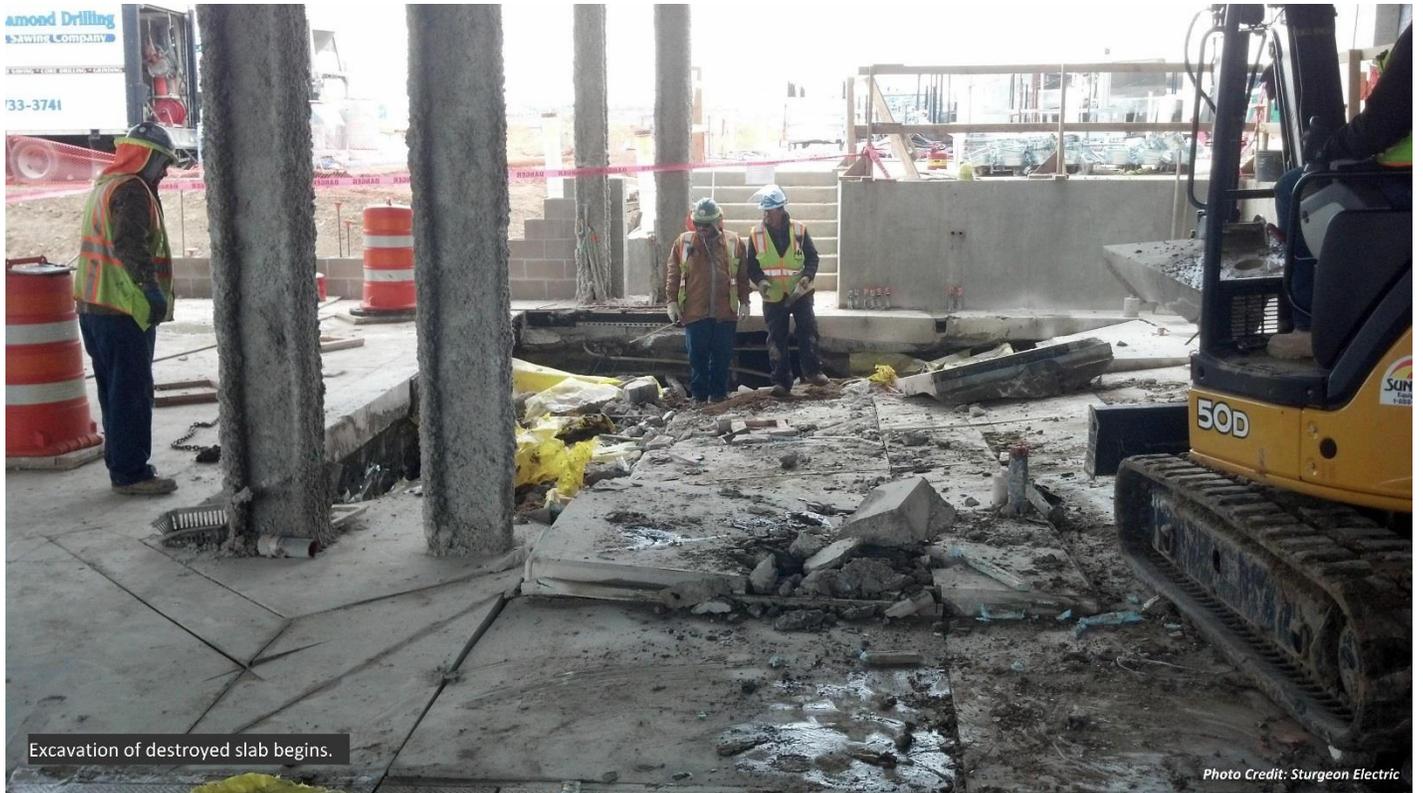
Excavation of destroyed slab begins.

As removal of the concrete slab and damaged utilities commenced, it was discovered that Sturgeon's underground installations stood unfazed, firmly intact despite the eroding floodwaters. This was credited to Sturgeon's best-practice approach; we opted to use flow-fill, a slightly more expensive type of conduit encasement, in lieu of the traditional squeegee method. As a result, 90% of our underground installations withstood the beating of the raging flood.

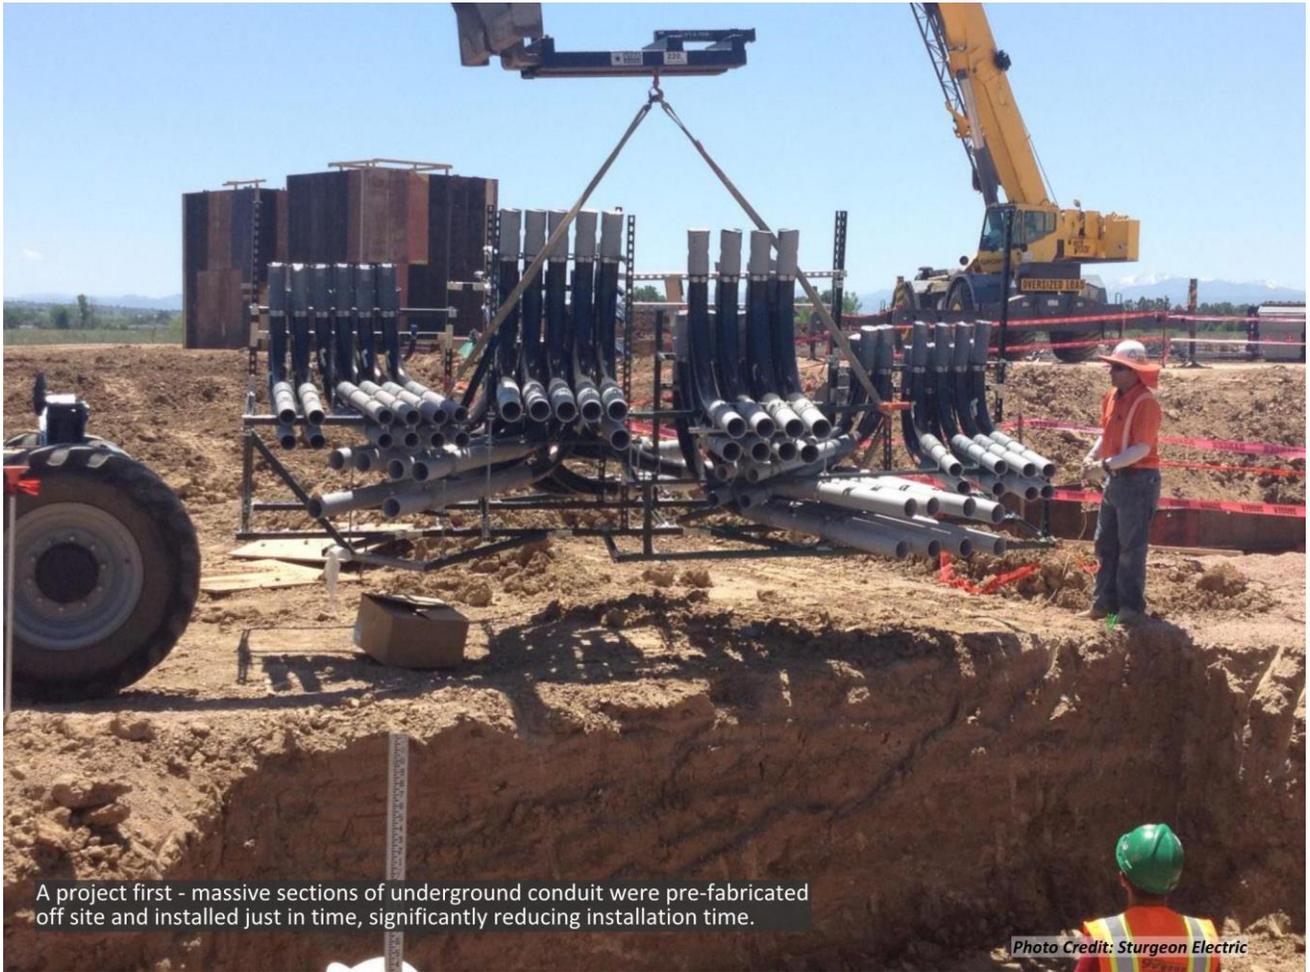
A project first - massive sections of underground conduit were pre-fabricated off site and installed just in time, significantly reducing installation time.

Long before the flooding, we needed solutions for compressing our work to meet the aggressive 18-month construction schedule. We targeted the underground installation at the Central Utility Plant. Our goal: assemble large sections of underground conduits off-site in a controlled location, to be delivered and placed underground at exactly the right time. This concept of just-in-time delivery of the massive conduit assemblies required a triad of in-house collaboration between our field leadership, prefab department, and BIM teams; the results were unprecedented. The effort was a massive success, as Sturgeon was able to install all of the underground feeders in just 10 working days. The time savings were colossal, providing a one-month gain over traditional methods of lay-in trench assembly.
