Category 3: Meeting the Challenge of a Difficult Job

Contractor: Saunders Construction, Inc.

Project Name: 9th and Colorado Project Implosion and Demolition

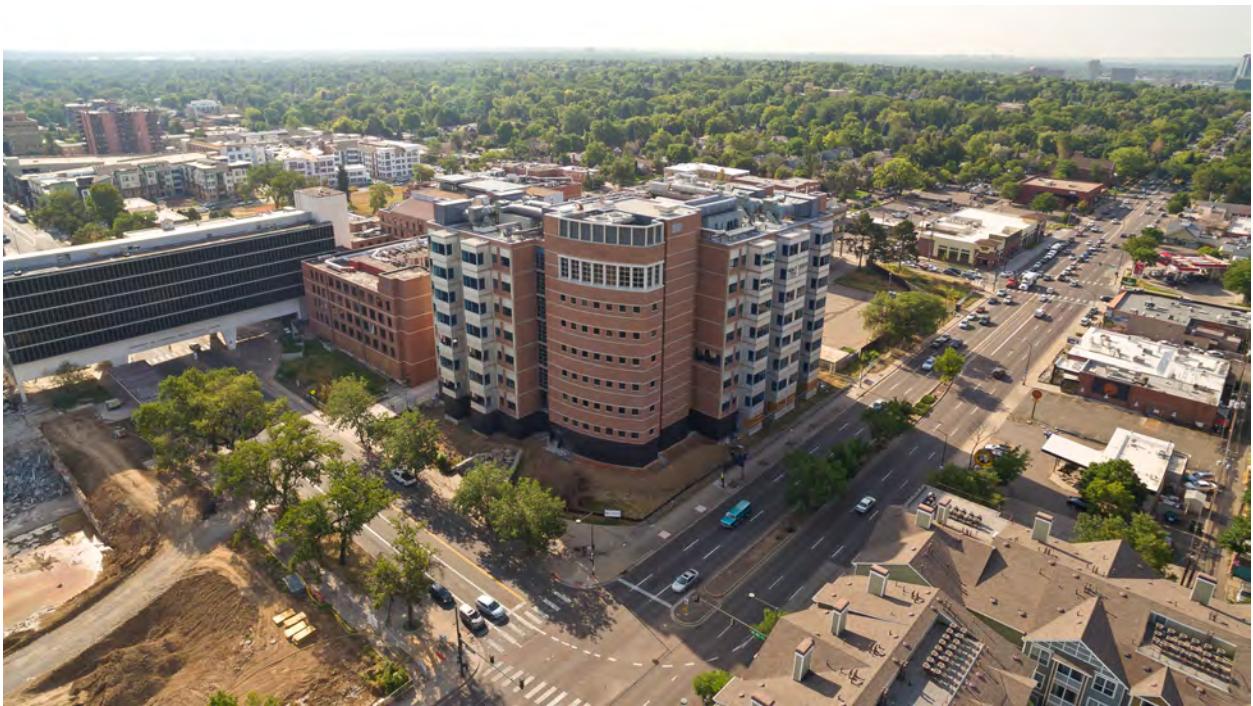
Photo Caption: BRB Before Implosion

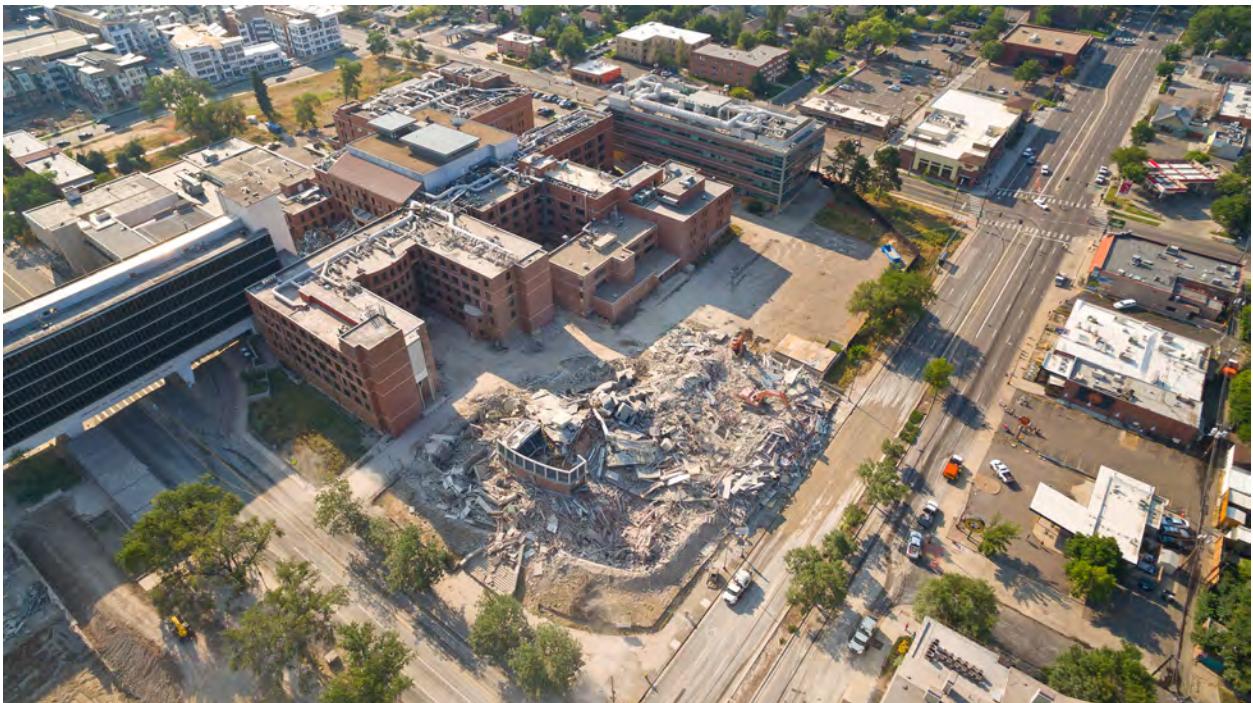
Photo Caption: BRB After Implosion

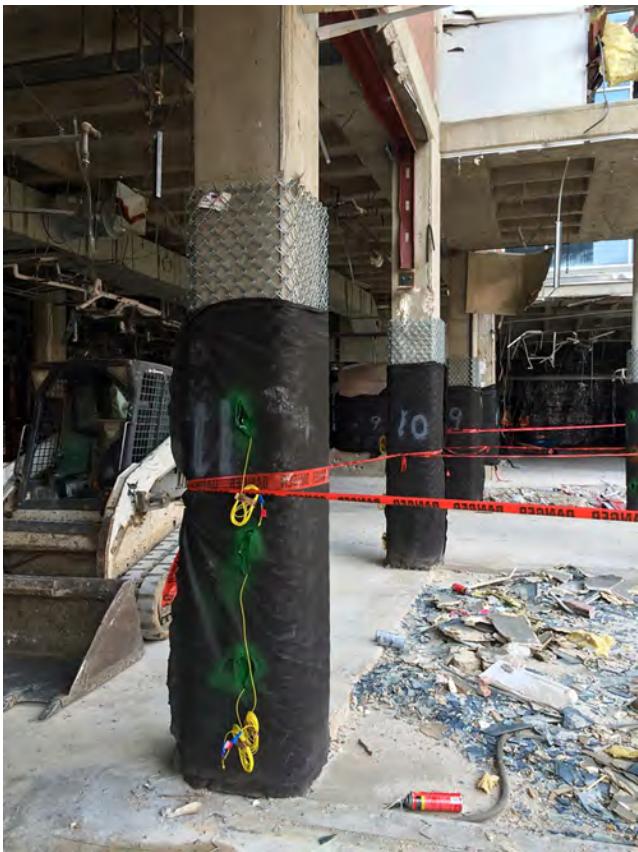
Photo Caption: Building Columns Prepped with Explosives
Credit: Saunders Construction, Inc.

Saunders then began a scrupulous process of planning, scheduling and preparing. Prep alone took four months. A former laboratory, the BRB contained equipment and materials (some hazardous) that had to be removed before being stripped down to its concrete skeleton. Meanwhile, the Saunders team began developing plans and schedules that covered the entire process “down to the minute before we pushed the button,” as Project Superintendent Bruce Fifer says. An equally detailed documentation set included plans for road closures, blasting, and neighborhood logistics. A master site map showed the blast sequence, road closures, dust control measures, and safety and control measures.

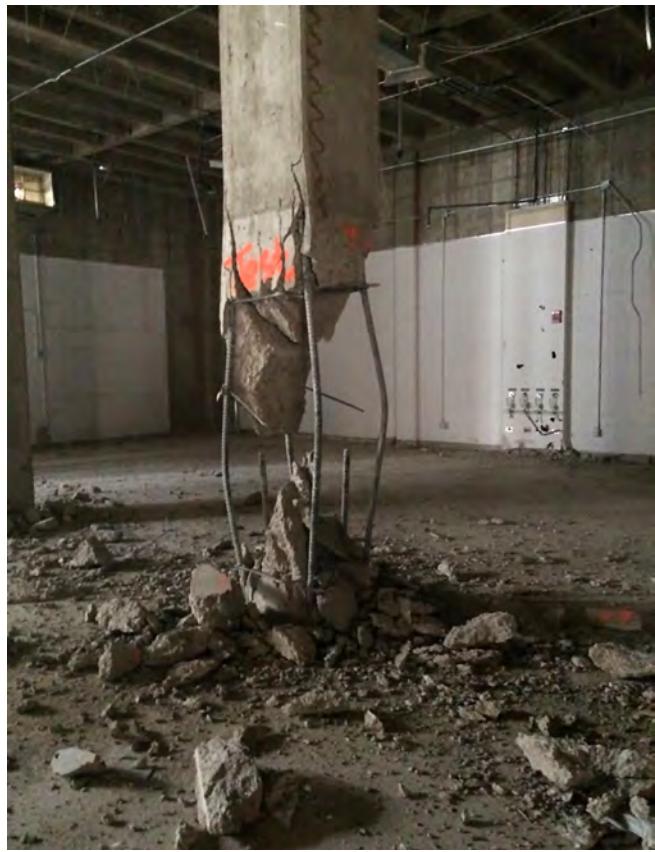
Photo Caption: Test Blast to Column
Credit: Saunders Construction, Inc.

The importance of minimizing noise, dust, and vibration impacts in the area was further intensified by the presence of three nearby medical facilities — Rose Medical Center, the VA Hospital, and National Jewish Health — including one dedicated to respiratory health and another that treats Post-Traumatic Stress Disorder (PTSD). Saunders coordinated closely with the neighborhood and the campuses to understand their concerns, allay fears, and mitigate impacts as much as feasible. Specific mitigation measures included noise barriers and the use of industrial mist equipment to keep the building damp, “weighing down” the debris and thereby minimizing dust. Additionally, to minimize noise, the team determined the minimum amount of explosives that would still bring the building down in a choreographed and safe manner. Months prior, the team weakened the structure by removing columns and walls that were pre-approved by an engineer. A few days before, with fire and police personnel onsite, test blasts were performed to ensure structural failure without overblast that could cause damage neighboring structures.

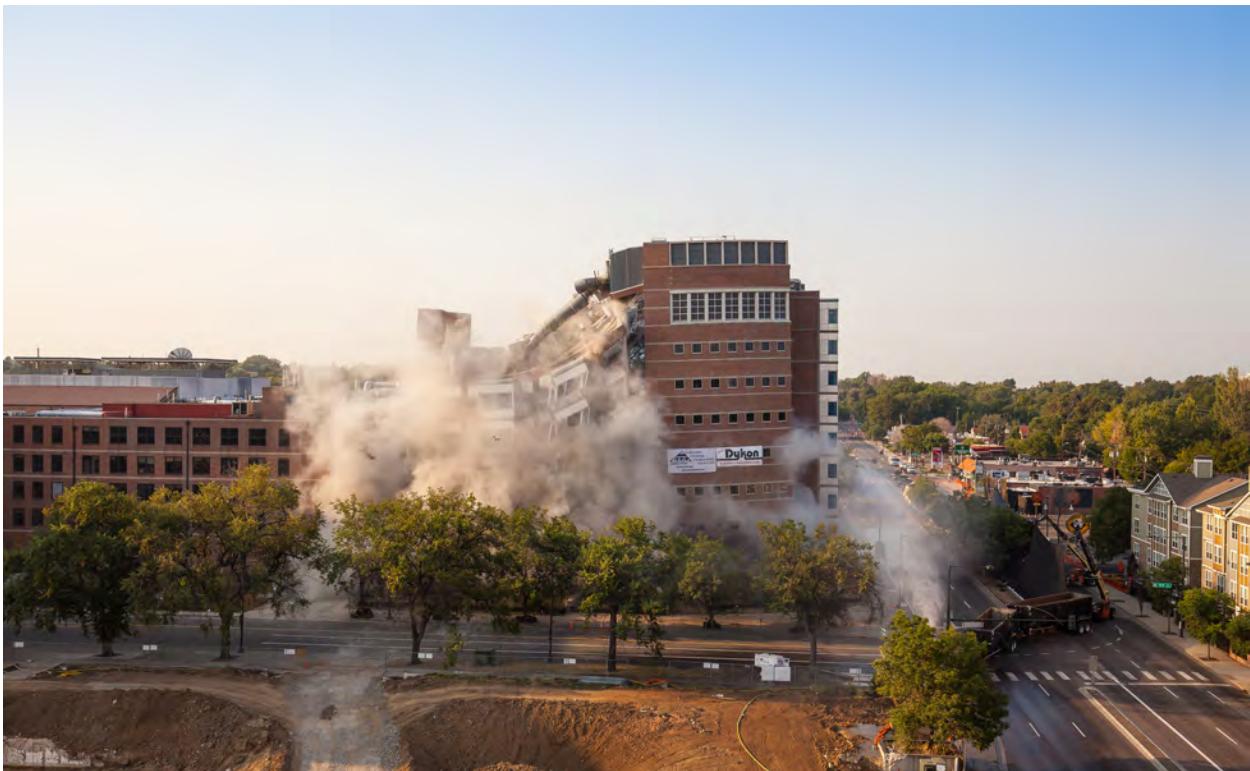
Photo Caption: BRB Implosion

On August 29, the intense preparation culminated as traffic control began at 3 a.m. and blast protection started at 4 a.m. Remaining safety measures were implemented two hours later and the team performed a one-hour walk-through. A crew of 60, including 20 Saunders employees, kept people out of the implosion zone. Two EMS crews and four fire trucks were also onsite. After a 7 a.m. “all clear,” events progressed to detonation at precisely 8 a.m. Project Engineer Allison Egan recalls, “I was amazed at how quickly the six hours (of preparation) went. And how the building fell exactly as designed, with only a tiny bit of debris.”

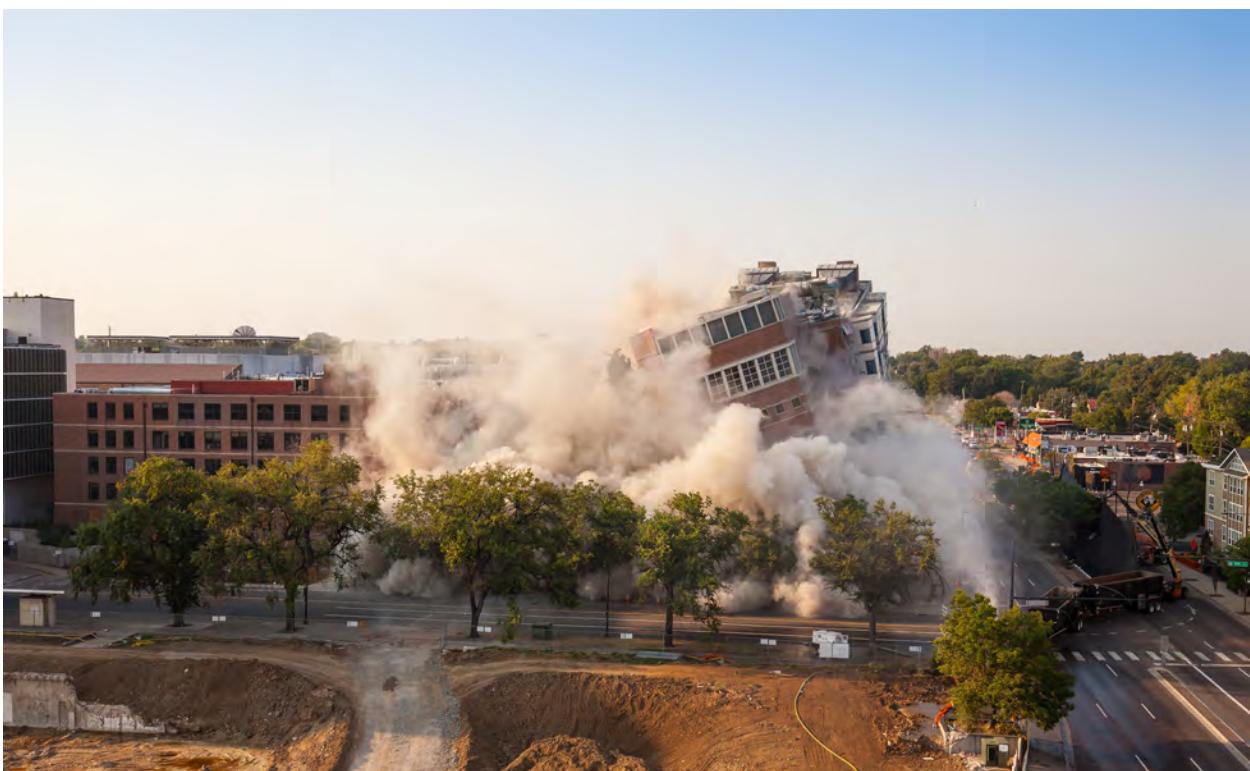
Photo Caption: BRB Implosion

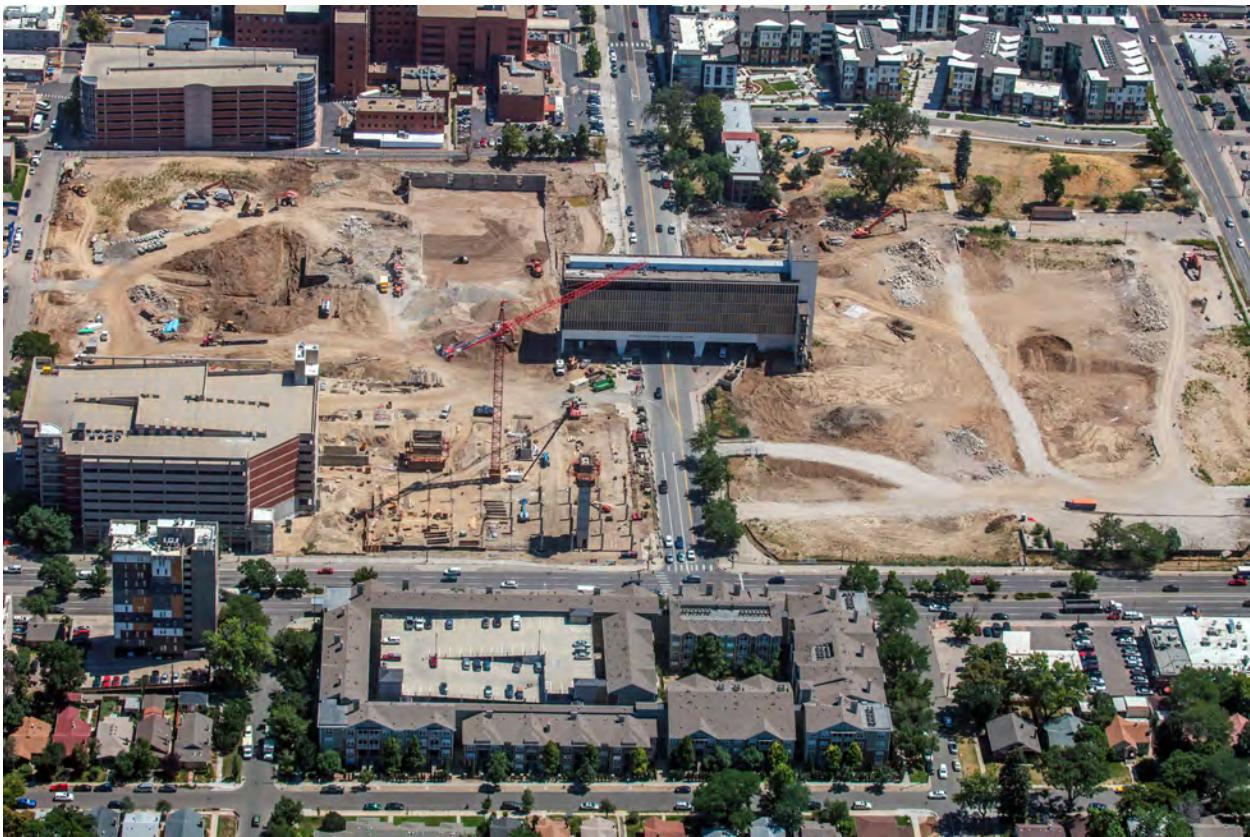
Photo Caption: Demolition Contract Complete – Start of Vertical Construction

As part of Saunders' sustainability initiative, approximately 44% of all demolition materials — total of 174,195 tons — were salvaged or recycled. The concrete, for example, was recycled as a new parking surface.
