Exacting Precision Proves Critical in Leading-Edge Lab Renovation

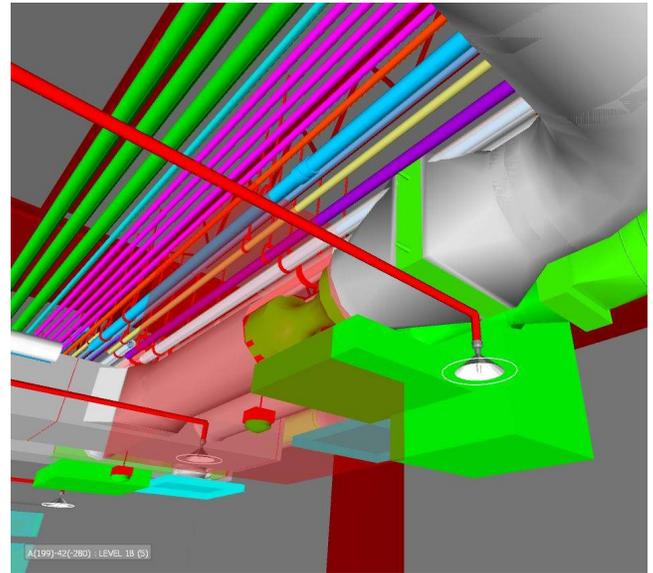
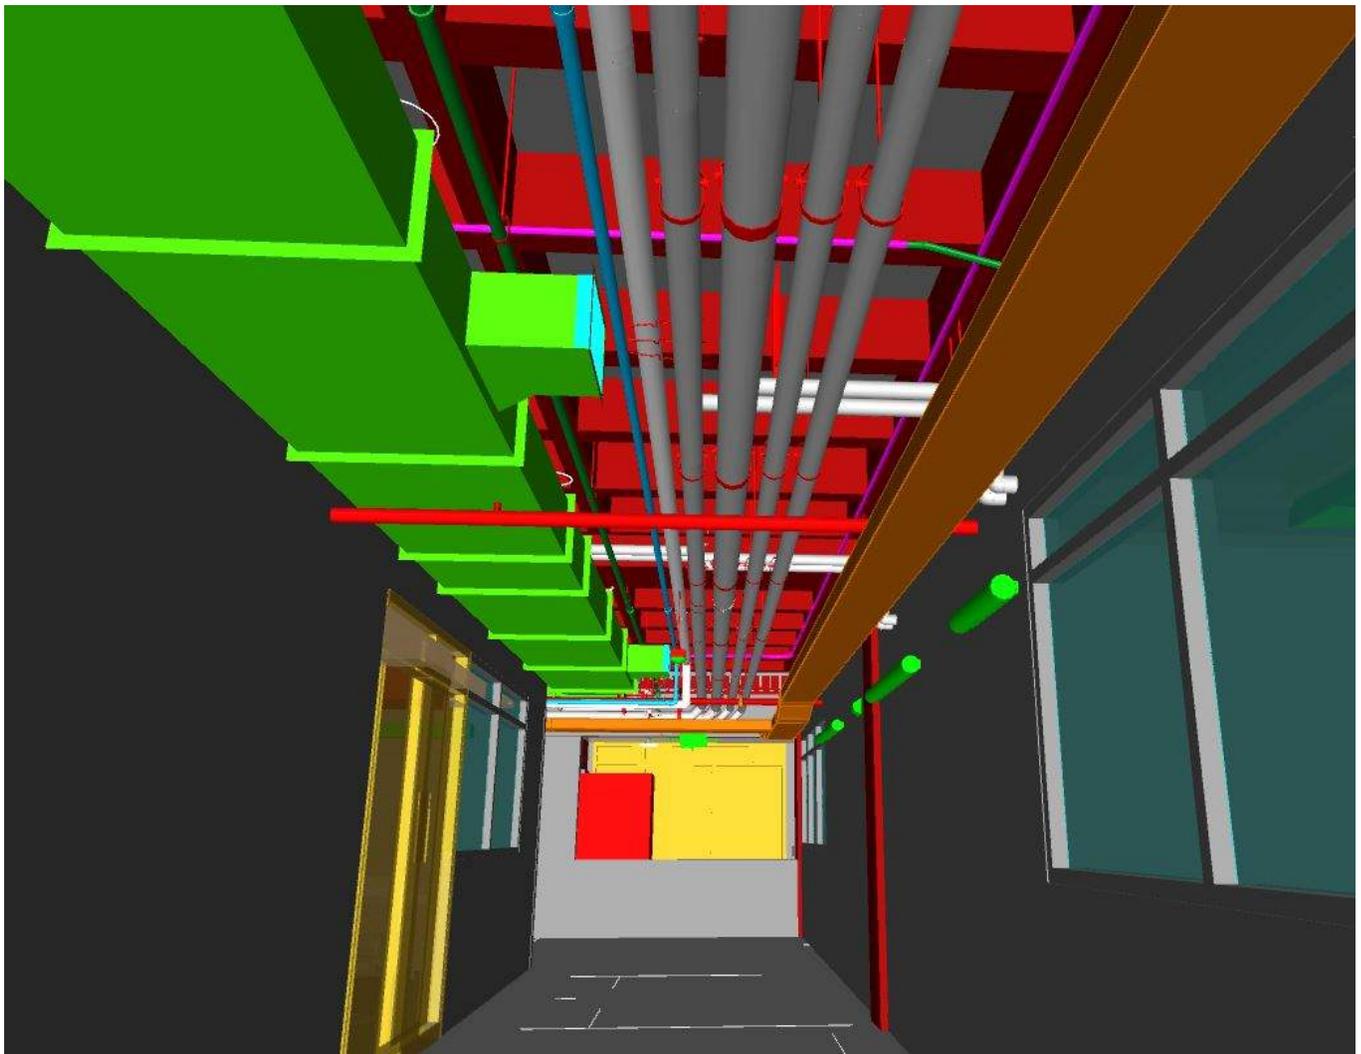
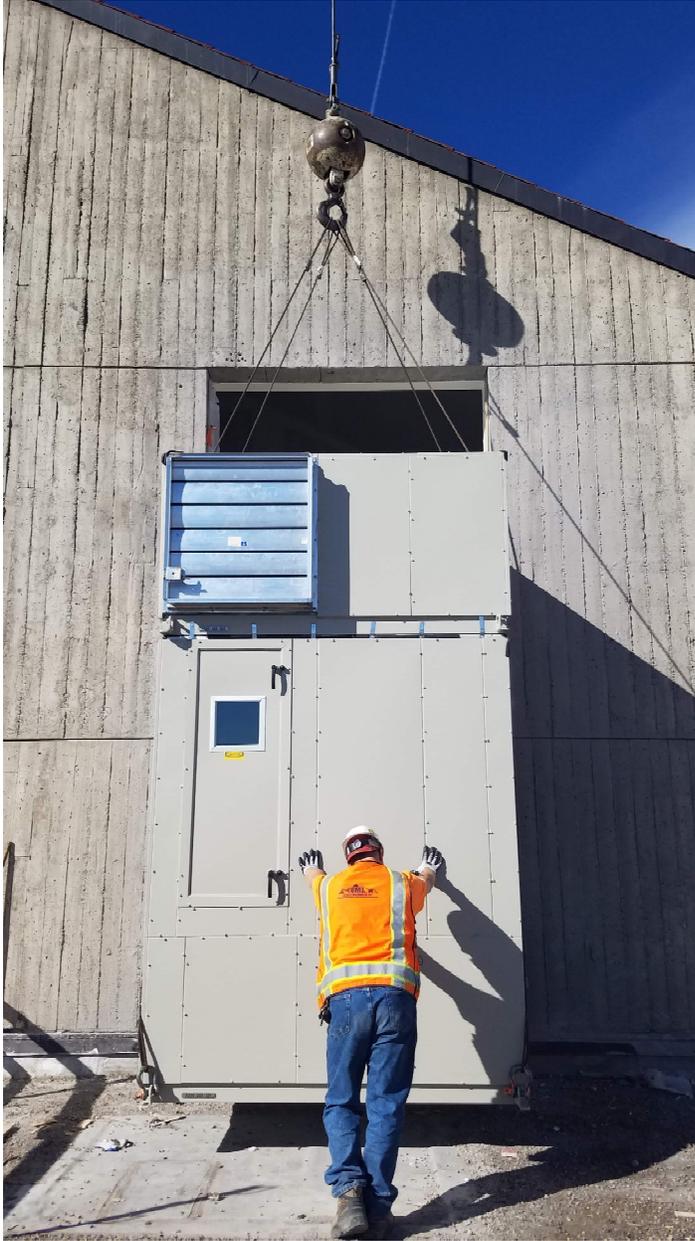
Most new laboratories are designed to have a deck-to-deck height of 16 feet to accommodate the complex mechanical/electrical/plumbing (MEP) necessary for optimal laboratory functioning. The maximum height here was only 12 feet. Legacy relied heavily on its building information modeling (BIM) to make it happen. Ultimately, everything was integrated...but frequently with clearances of less than ¼-inch between systems.
