## **Category 2 – Meeting the Challenge of a Difficult Job – Specialty Contractor**

**Contractor: Fiore & Sons, Inc.**

**Project: 70 Ranch Reservoir**

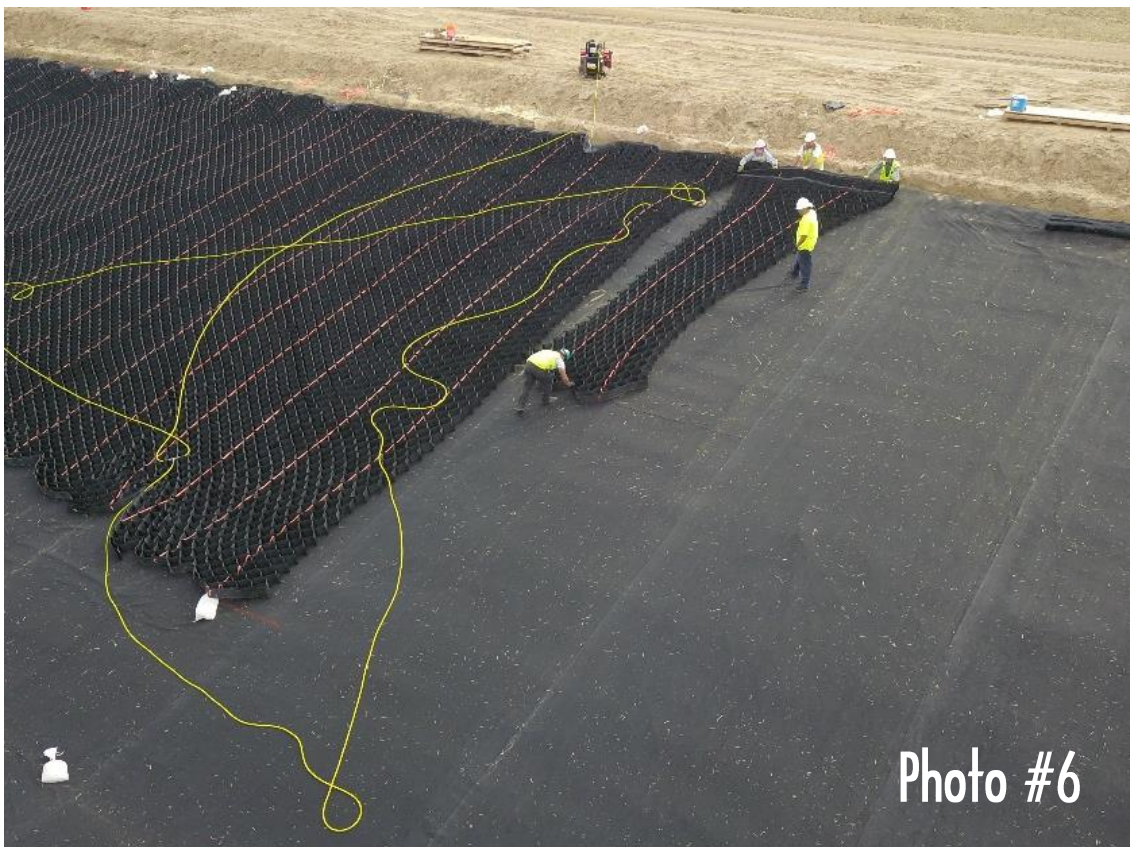
Aside from adequate protection at the riverside, and diversion of large rip rap and sheet pile to protect the structure from savaging floods, the reservoir has a unique revetment design. (Photo #6) The revetment, a four-part system made up of 8 oz. per sq yd Geotextile, atop 45 mil Geosynthetic pond liner, beneath GeoWeb open cells secured together tangentially with TP-67 Tendons and filled with 2-inch minus angular aggregate filler, was assembled on 4:1 slope in very sandy to gravelly soils. The project complies with stringent fine grading to 2” tolerance as required by CO State Engineer for jurisdictional impoundments & project specs. (Photo #7)

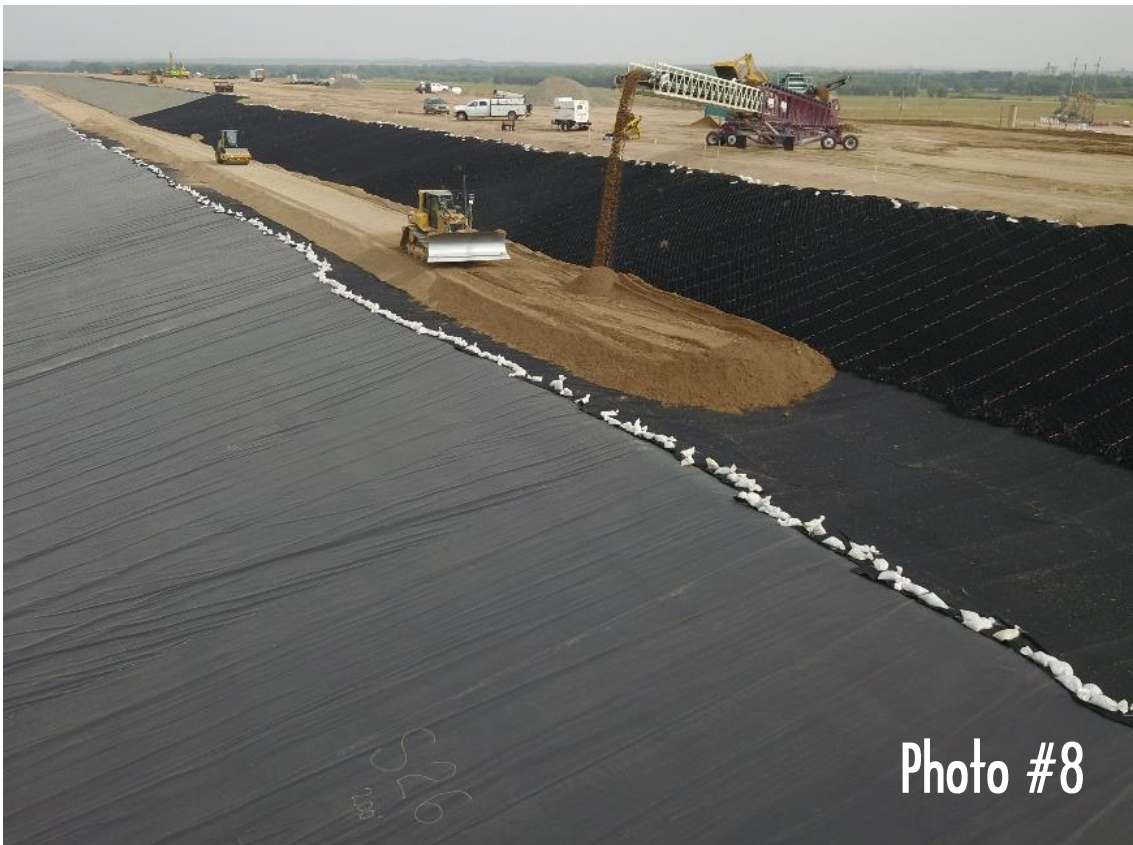
every pocket was filled to the correct height, all under inspector's watch. The break in slope, two-thirds up the dam face, created a narrow ledge that was covered with aggregates. The solution to this "limited access" problem was a conveyor/stacker (Photo #8) that delivered aggregates and soil to a waiting wide-track CAT Dozer that evenly applied material along the ledge to overlap with the now-filled cells.

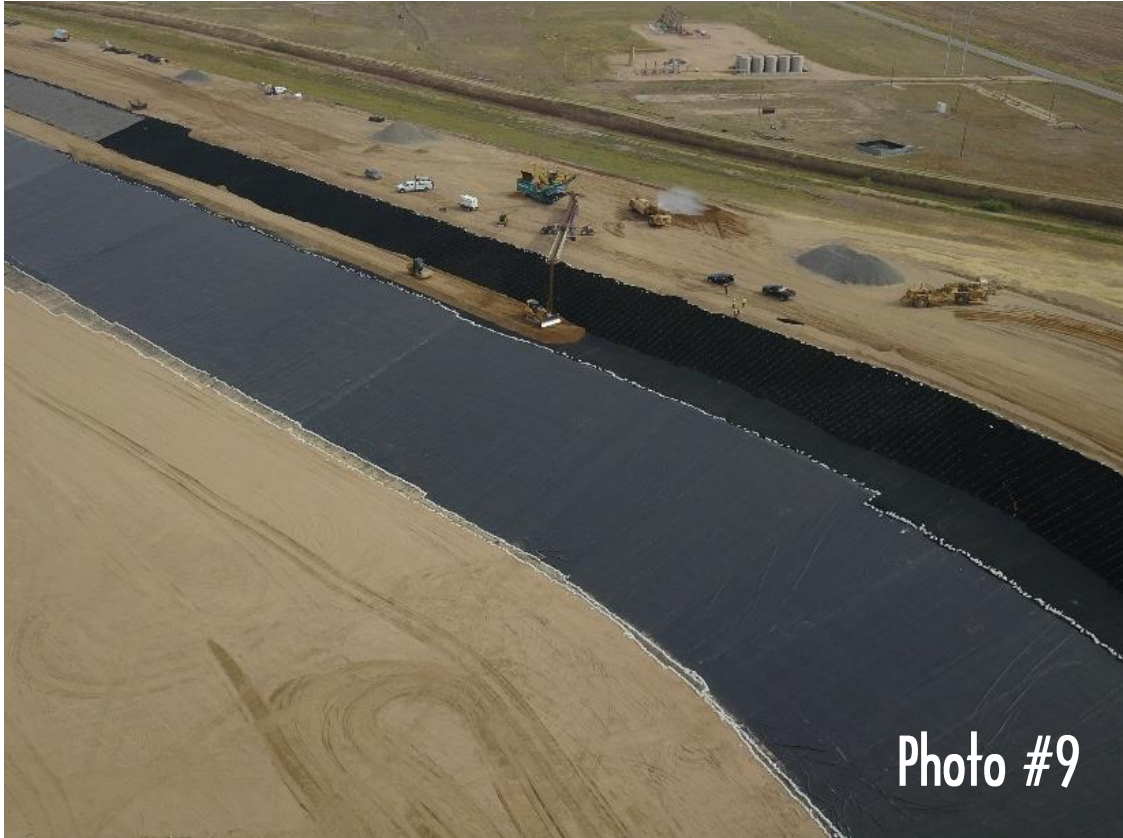
Photo #9

**INNOVATIVE SHORE EROSION CONTROLS** - The application of the pond liner underneath a cellular stone filled revetment is not common. Often their intended purpose conflicts with liners being smooth and revetment materials puncturing the liner thus reducing effectiveness. Although common to see filter fabrics underneath revetments, setting the cells atop a water proof liner is uncommon. Application of a multi-layer system of liner fabrics, open cells and strategically placed aggregate fillers is a unique application of all otherwise well-known products. Innovation about how to best integrate established and available materials in a large quantity to meet the ultimate goal of water conservation; slope erosion controls with a long service life; and meeting the budget for costs vs storage value, were all accomplished through the incorporation of this new idea. Innovation for the application of mining equipment with a conveyor stacker to carefully place the materials on the slope, in the cells and atop a narrow bench, helped ensure the installed system met design requirements. (Photo #9)
