Category 2: Meeting the Challenge of a Difficult Job – Specialty Contractor

Specialty Contractor: Colorado Cleanup Corporation

Project Name: Research Bridge Demolition

Bridging the Gap from Challenge to Success

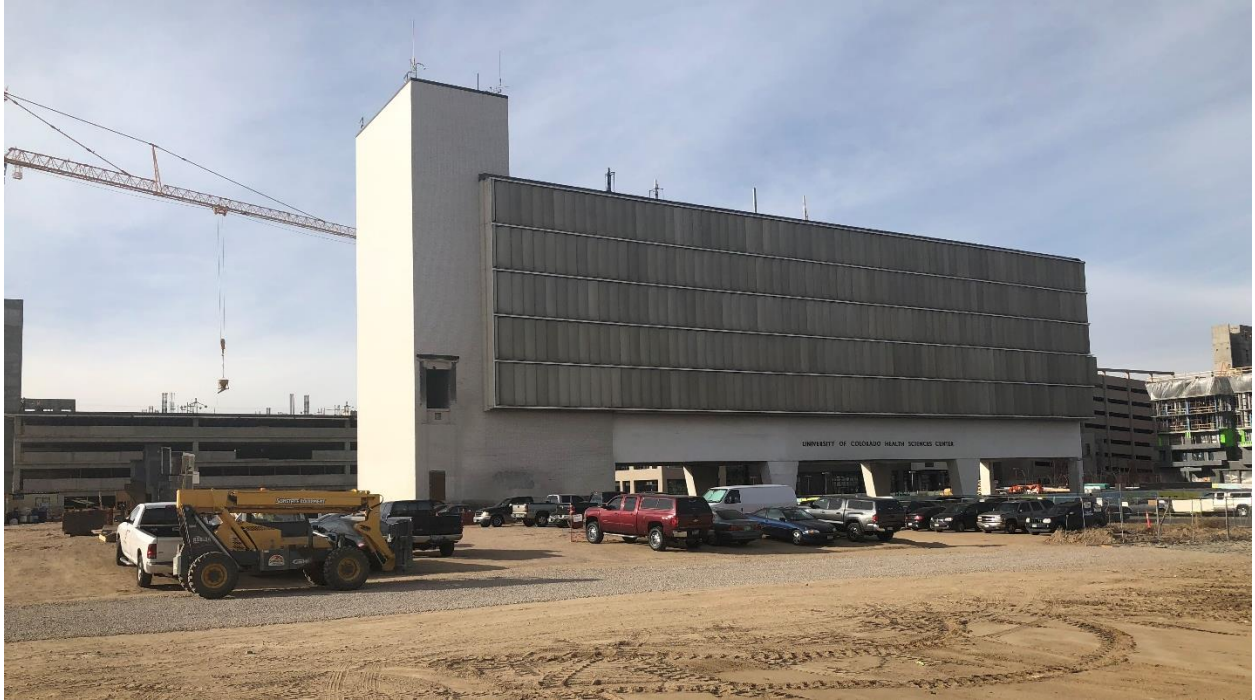
Photo 1: University of Colorado Health Research Bridge Prior to Demolition Activities

The Research Bridge structure consisted of five levels of office and laboratory space situated on top of an enormous three-span box girder system. Each girder was over fifteen feet tall and five feet thick, and reinforced by #18 rebar which is over two inches in diameter. With the offices stacked on top, the building was well over 100 feet tall. These characteristics gave rise to two main concerns: would the structure be able to maintain a balanced load on the girders during demolition to prevent toppling, and would we be able to reach the top of the building with an excavator?

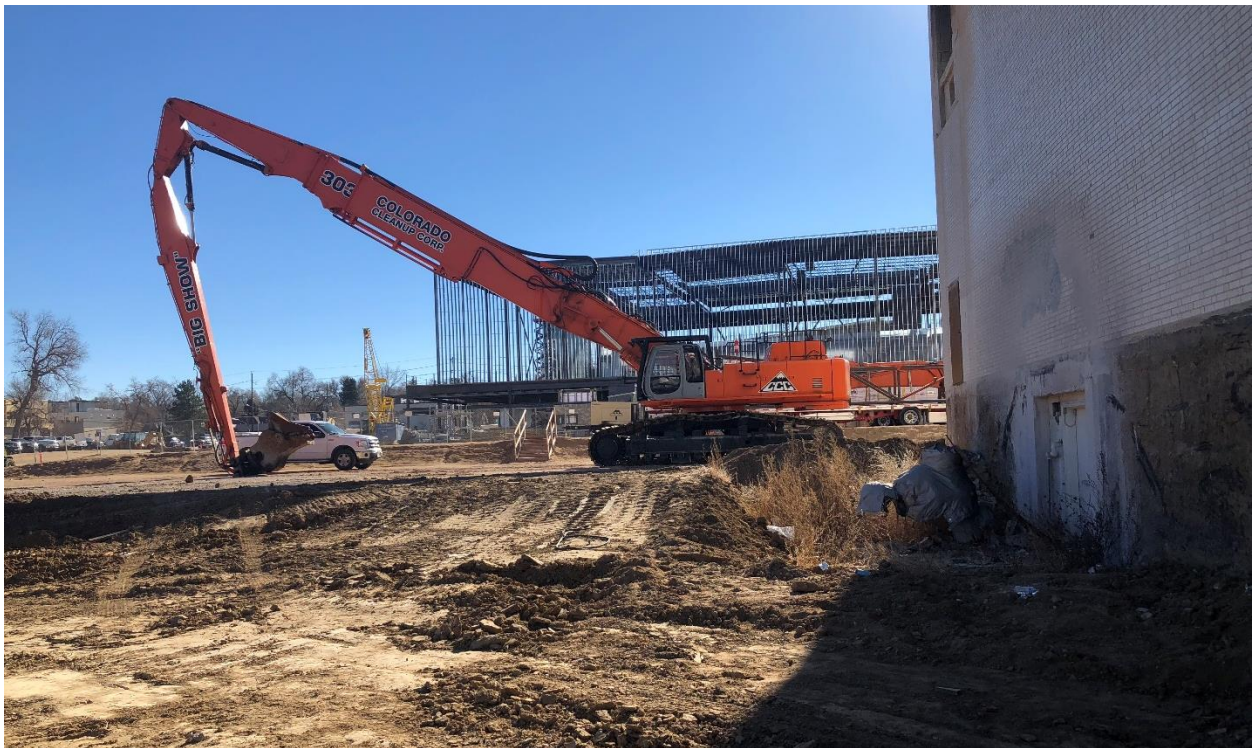
Photo 2: "The Big Show," CCC's High Reach Excavator

The next hurdle was the equipment. Conveniently, CCC had an ace up our sleeve; we had recently purchased a Hitachi 750 High Reach Excavator for other work at 9th and Colorado. The machine came to Colorado all the way from Europe and was, the only specialized demolition piece of equipment of its kind in the region. With a working height of 145 feet, it was uniquely ready to take on this massive task. CCC also employed the use of multiple Dust Boss demolition dust control units to conform to dust control requirements. The Dust Boss unit can disperse a fine mist over a larger area than the traditionally used firehose with less water used overall, and the same amount of dust control.

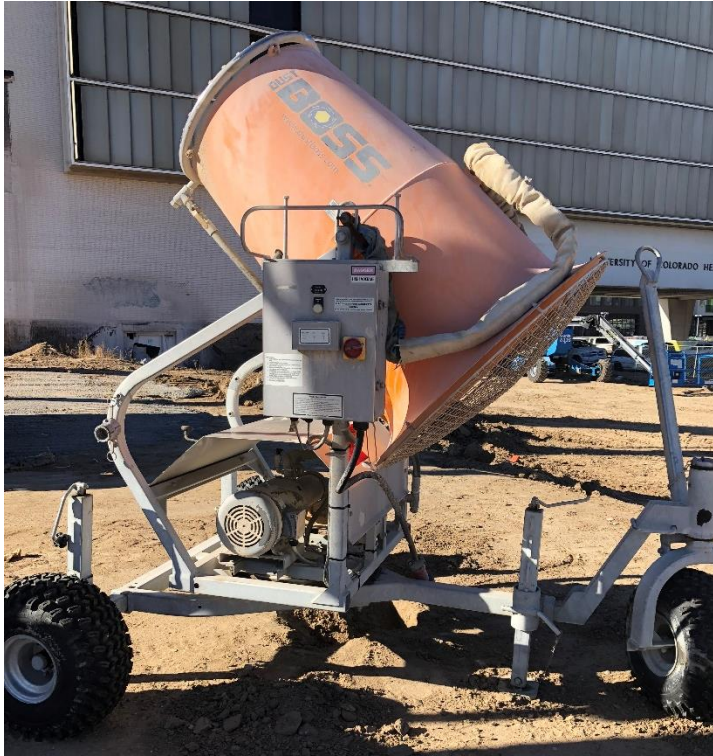
Photo 3: Dust Boss Dust Control Unit

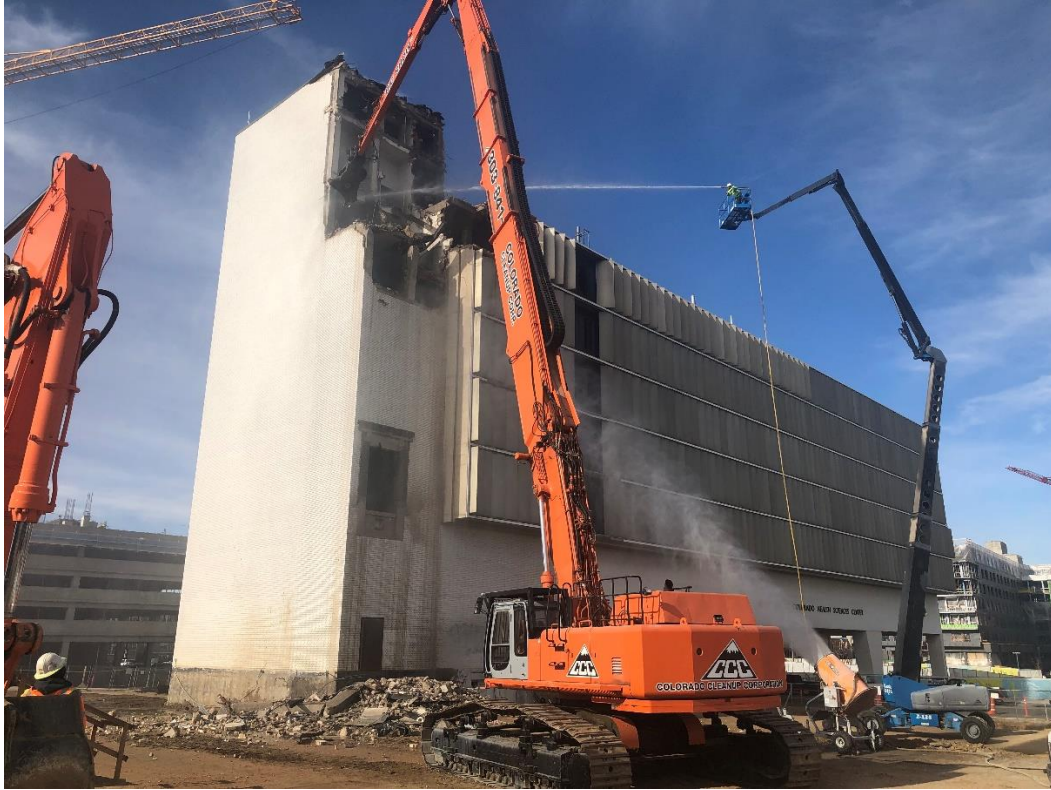
Photo 5: Dust Mitigation Techniques in Action

Throughout the project various steps were taken to maintain the safety of our crew and nearby residents. First of all, a restricted work zone was established. No workers were permitted to be near the structure during demolition with the exception of the excavator operator. Secondly, because dust was a risk, silica respiratory tests were conducted at regular intervals to put quantitative values to the dust mitigation. The Dust Boss units were supplemented by workers on a man lift with a firehose who could spray trouble areas with additional water as necessary. Special emphasis was made to these workers on fall protection and safety before they were allowed in the lift.

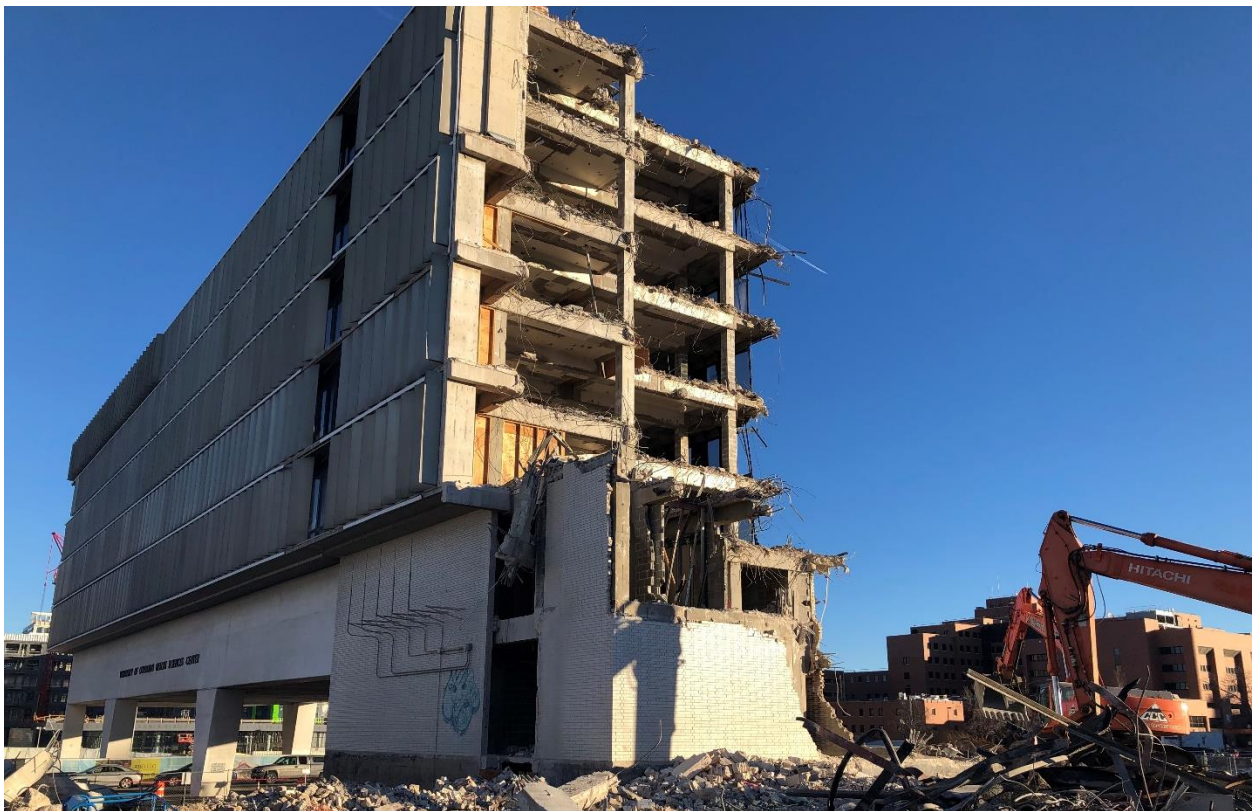
Photo 6: Building Cap on South End Nearly Completely Removed

The demolition consisted of 26 phases starting at the top of the South end of the bridge. There was still a partial building capping that end of the bridge and it was the first thing to be demolished leaving the girder system and overlying offices intact. Next, the equipment was

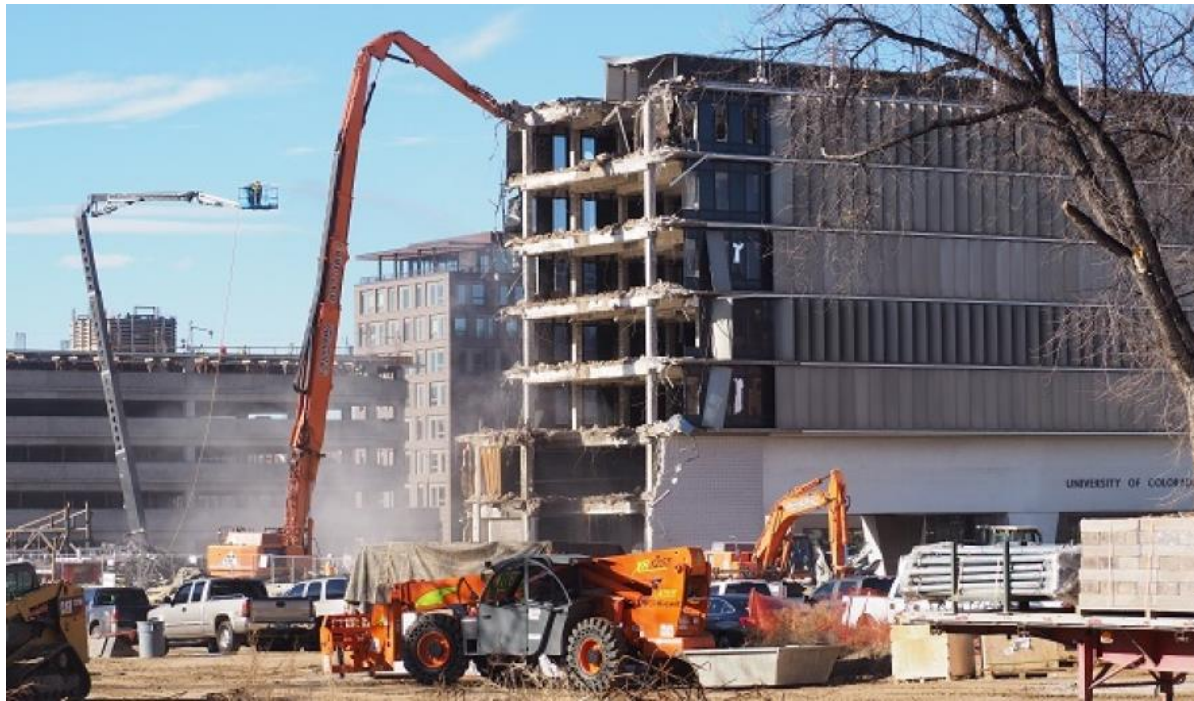
Photo 7: Demolition Begins Over the Girders (Used with permission from Reporter/Photographer Thomas Gounley)

moved to the north end of the bridge and started by removing the penthouse level to half of the North girder system's length. The roof system and support beams were then removed to a quarter of girder's length, followed by the structural systems of the top floor. The process was repeated until the top level was removed to the extent of the removed penthouse level, and then again for each subsequent floor below. The second half of the building over the North girder system was deconstructed in the same process, floor by floor, until the girder was the only thing remaining for the North third of the structure. The whole process was then repeated for the south span of the bridge, and then the center span. Some of the center span remained to maintain the lateral stability of the girders.

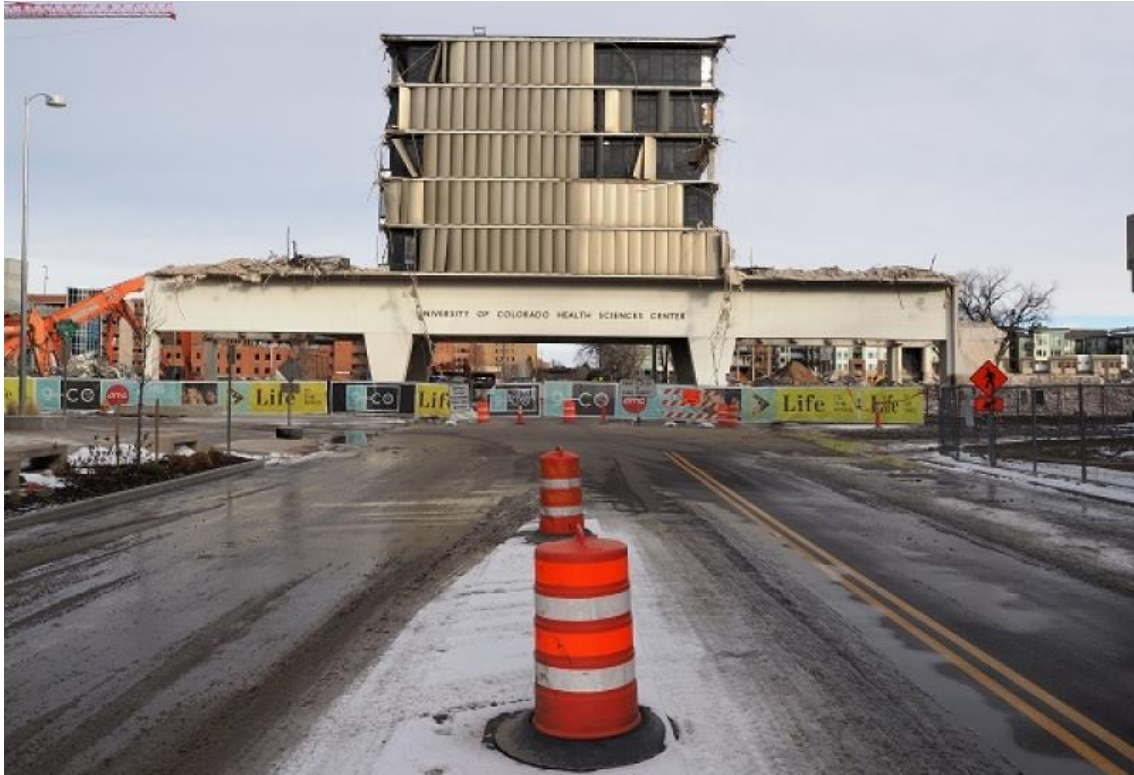
Photo 9: North and South Sides of Structure Completely Removed (Used with permission from Reporter/Photographer Thomas Gounley)

With the North and South girders now completely unladen, they could be demolished. The South girder span was first to be removed, and then the North. This left a single girder span in the center with office levels still above. The structure was removed with the same process as the other girder spans. Finally, the central girder system was unladen and therefore ready to be demolished. The protective measures on the roadway were removed and the road reopened to the public.

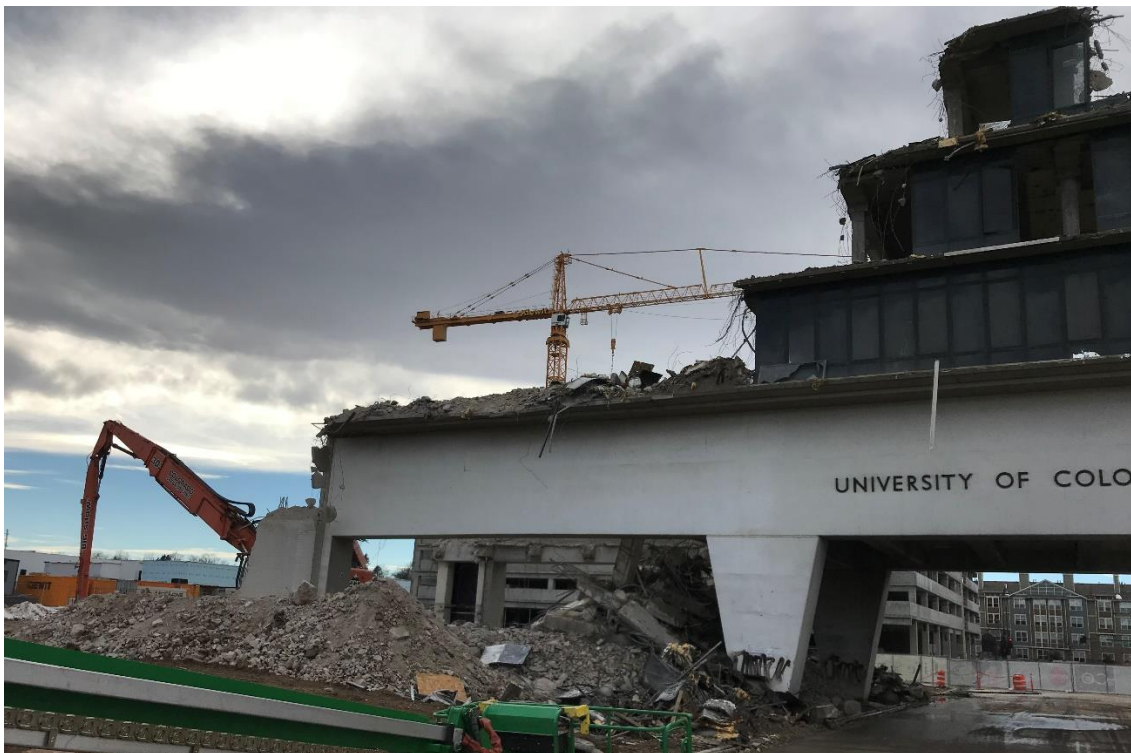
Photo 10: Demolition Begins on the Girder Sections
