Ivinson Memorial Hospital Medical Office Building 3rd Floor Addition

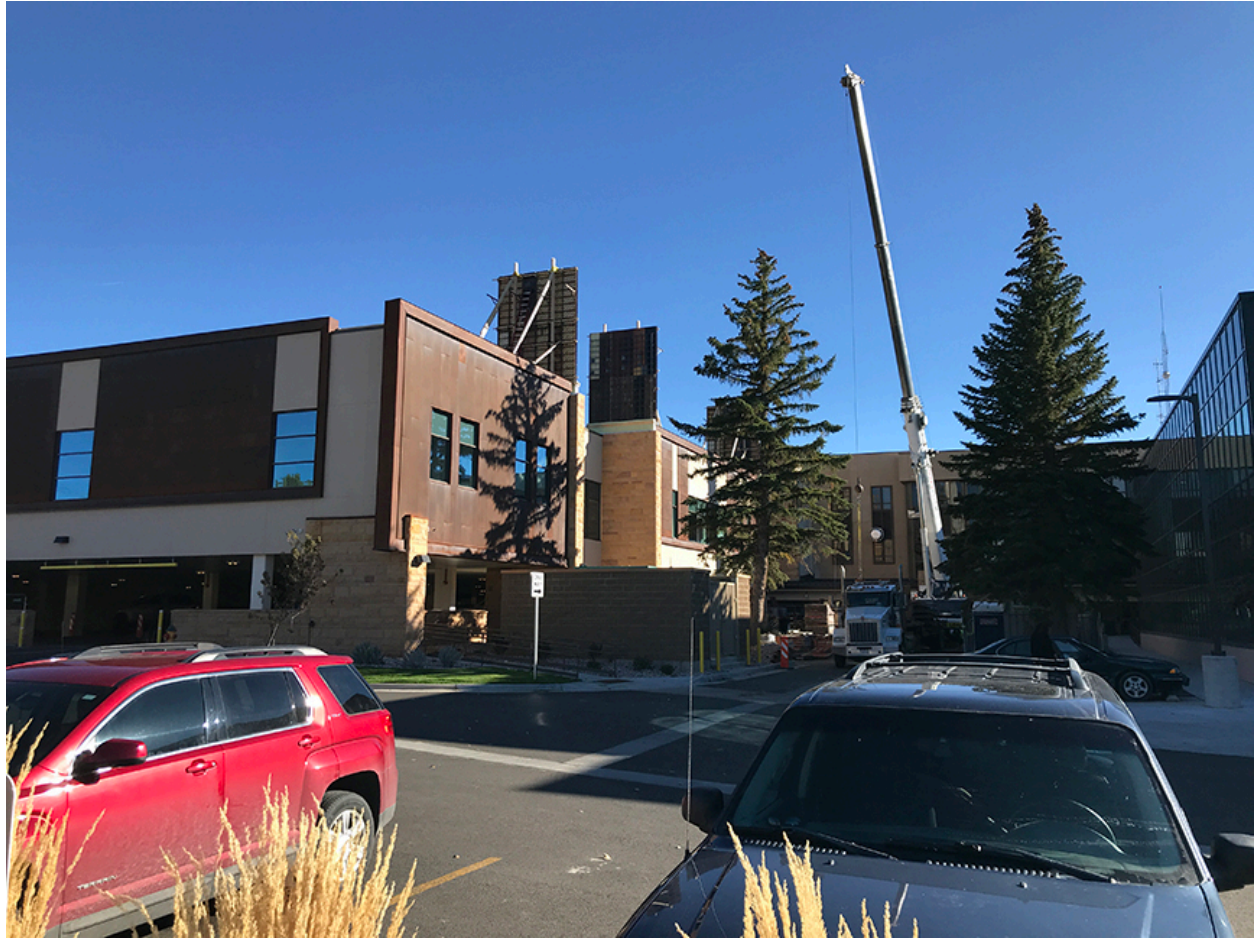
Providing access to the extended shear walls [Picture 4] also proved exacting. Once the concrete was poured, we constructed a scaffolding system [Picture 5] that allowed the steel erectors, then monocoaters, waterproofers, and masons to safely carry out their trade.
