Category: Best Building Project (Under \$10million – General Contractor)

Contractor: Saunders Heath Construction

Project Name: Windsor Mill

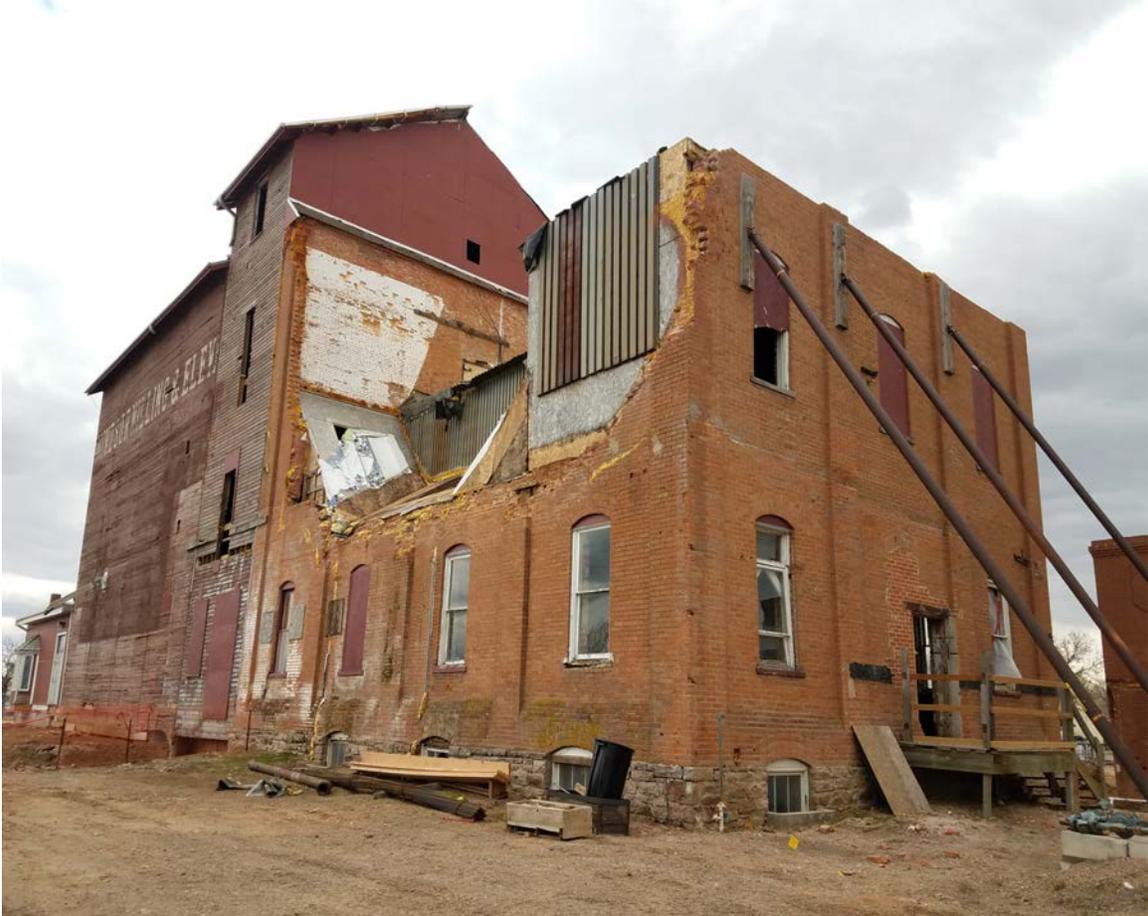
The Windsor Mill pre-construction in 2017. Nine years after a tornado ripped through the town and tore off half of the second story of the brick building.

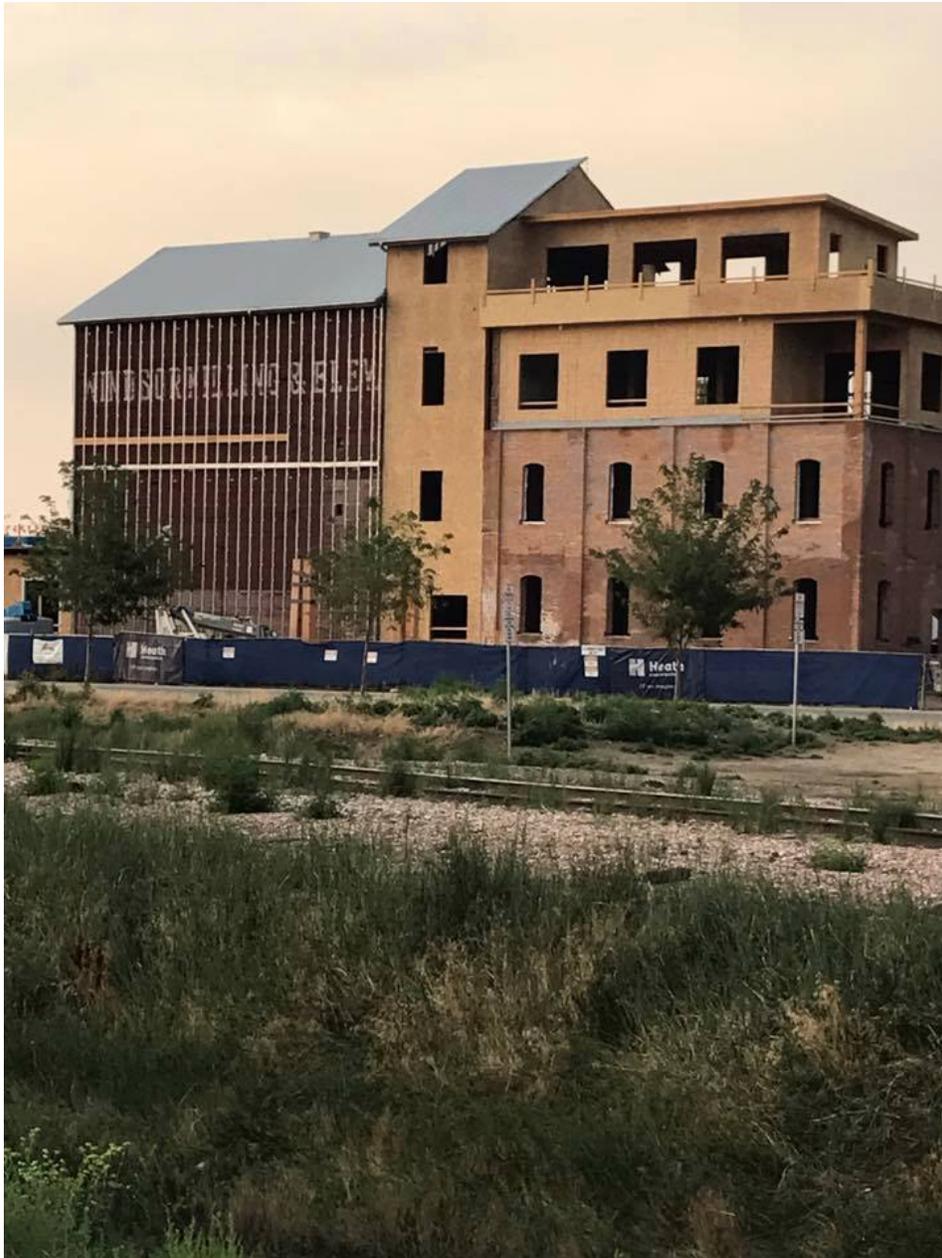
The Windsor Mill – August 7, 2017 the morning after an arsonist burned down the building.

In the early morning hours of Aug. 6, 2017, the historic Windsor Mill (The Mill), in Windsor, Colo., went up in flames as an arsonist set fire to the small town's iconic building. Saunders Heath was just shy three months from completing the core and shell construction of the building. The 119-year-old structure had faced many misfortunes from the beginning — suffering its first fire nine years after it was constructed in 1899, a tornado in 2008 left it vacant and abandoned for a decade, and then just as it was being brought back to life in 2017, an arsonist left the historic building in almost complete ruin.

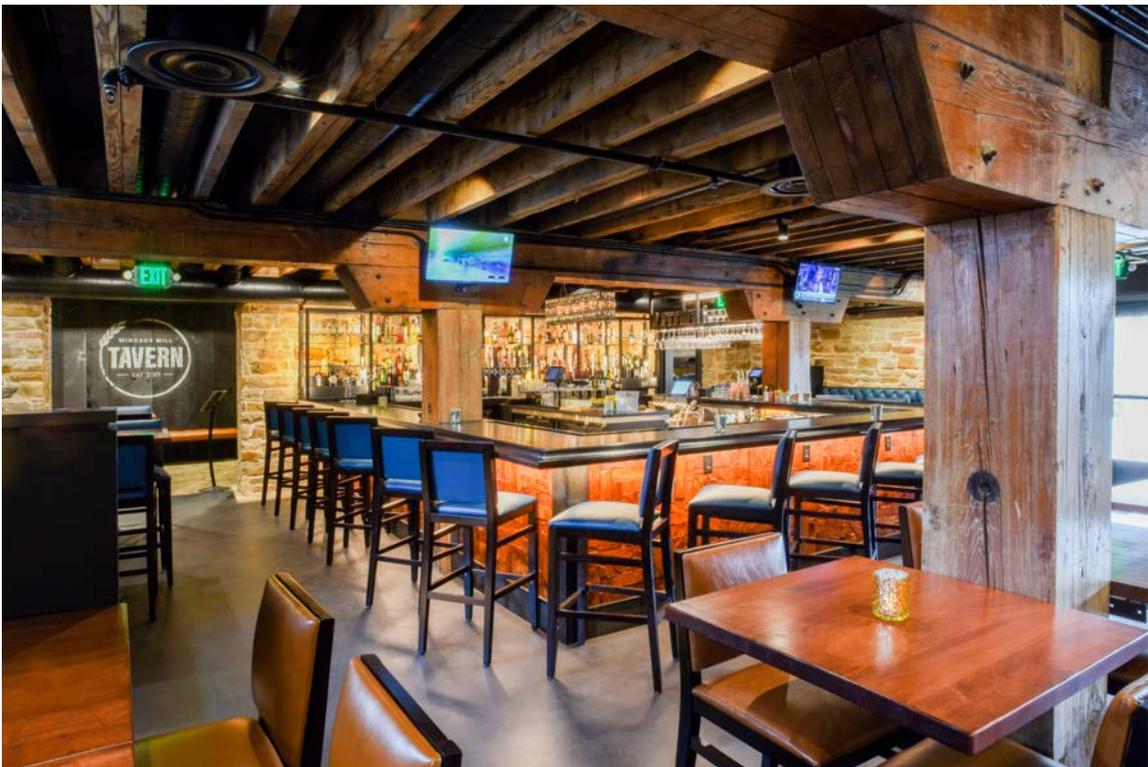
The Basement of the Windsor Mill 2019. The majority of the original brick, timber and joists were salvaged from the fire.

The use of true heavy timber and faux heavy timber where structural elements were exposed and tying these elements together in a seamless manner challenged both the design and construction team on various levels. As an example, the second floor rough sawn 3x12 timber joists and 12x12 timber beams were severely damaged in the 2017 fire. The damage was wide spread and random, not constrained to a certain area of the ceiling that was to be left exposed. The project team worked with the architect, engineer and owner constantly through site meetings to develop a plan to disassemble the entire ceiling and some of the timber support structure and put it back together with a mix of reclaimed and new timber. The end result represents the path of the fire and provided a beautiful finished product.

During the 2017 historical renovation, owner and developer Blue Ocean Enterprises stored all unused existing brick and timber materials from the original Windsor Mill at an off-site location. Unaware at the time, their ability to salvage these materials would play an integral part into rebuilding of The Mill in 2018 after arson destroyed most of the original building. The post-arson remnants left a single-story brick box sitting on a nearly untouched stone foundation. After the fire, the design took on a life to pay respect to the historic mill. The additive vernacular of The Mill construction became the team's focus. The gabled roof and elevated volume at the front honor the historical shape of The Mill. The eastern single-story volume was wrapped in a rich red ship-lap siding, which
