**Category 2:** Meeting the Challenge of a Difficult Job – Specialty Contractor  
**Specialty Contractor:** Colorado Cleanup Corporation  
**Project Name:** EVRAZ Project Palmer

### **Cleaning Up for the Next Generation**

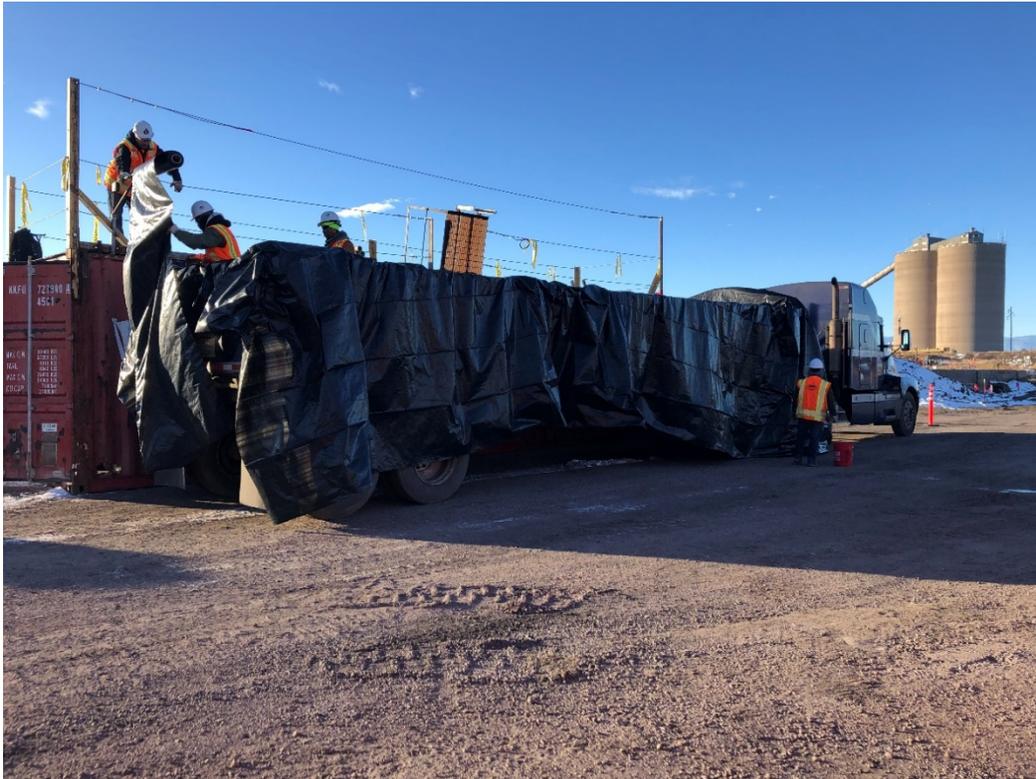
Figure 1: Lining Station

CCC planned for safe transportation and proper disposal of the contaminated soils. All the RACS waste was loaded into tractor trailers and shipped to a certified asbestos landfill. Because each load of RACS was required to be sealed in leak-tight liners, CCC engineered state-of-the-art lining and wrapping stations (Figures 1 through 4). These stations allowed technicians

to safely install plastic liners in the trailers, and seal liners after the RACS was placed into the trailers. The lining station consisted of a shipping container with protective rails installed on the top to give workers access to the trucks. A ladder on a hinge could be dropped into the bed of the truck allowing workers to climb and begin lining the truck. A rotatable arm held a roll of plastic at the end of the trucks for workers to pull the sheets over the truck beds. The workers inside the truck draped the plastic over the sides of the truck. Workers on the ground pulled the plastic tight and secured it against wind with clips to the sides of the truck (Figures 1 and 2). At the loading stations a drop cloth of 10 mil plastic sheeting was placed on the haul road to prevent any spillage from contaminating the clean road (Figure 3).

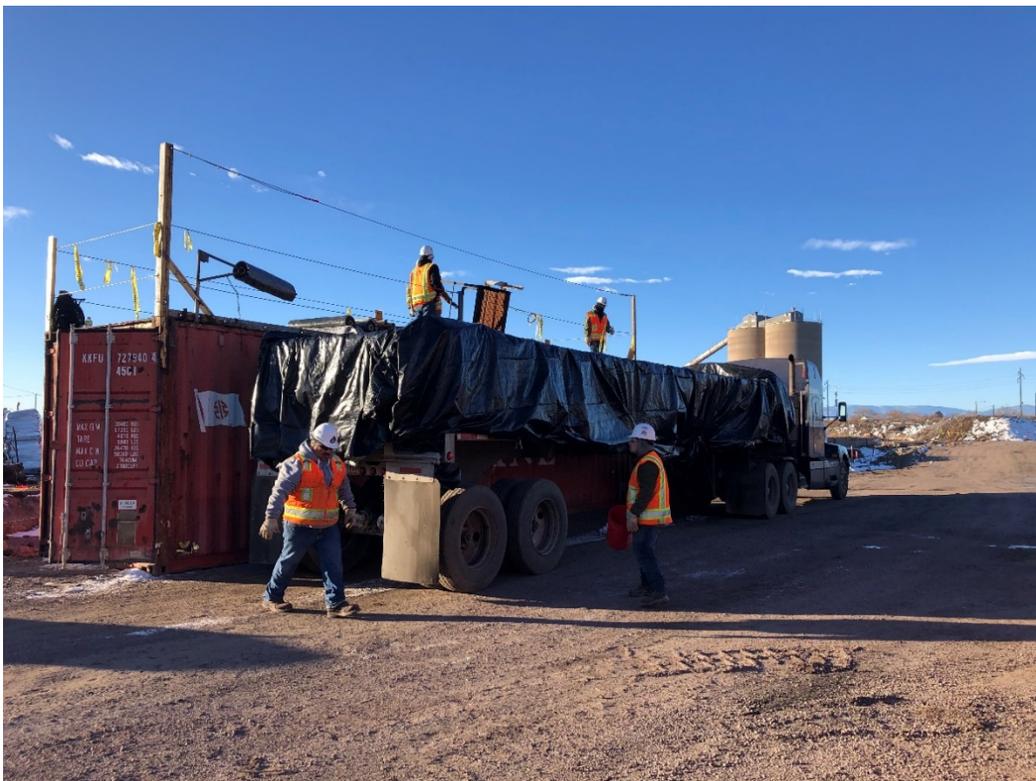
Figure 2: Truck Ready to Proceed to Loading Station

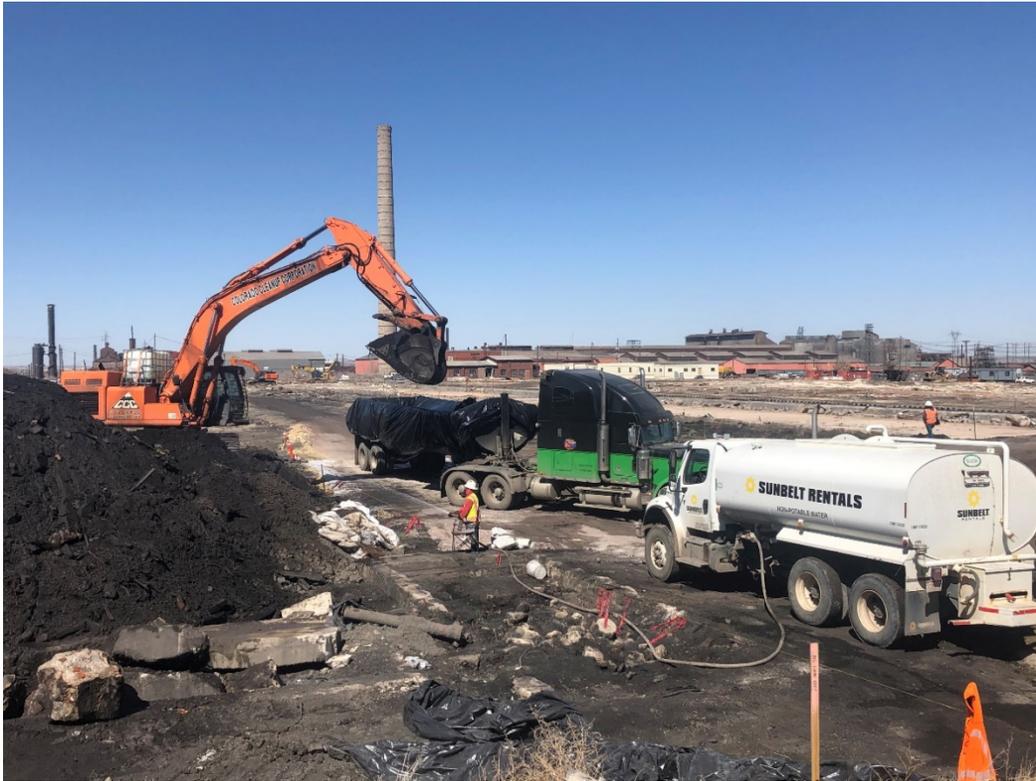
Figure 3: Loading Station

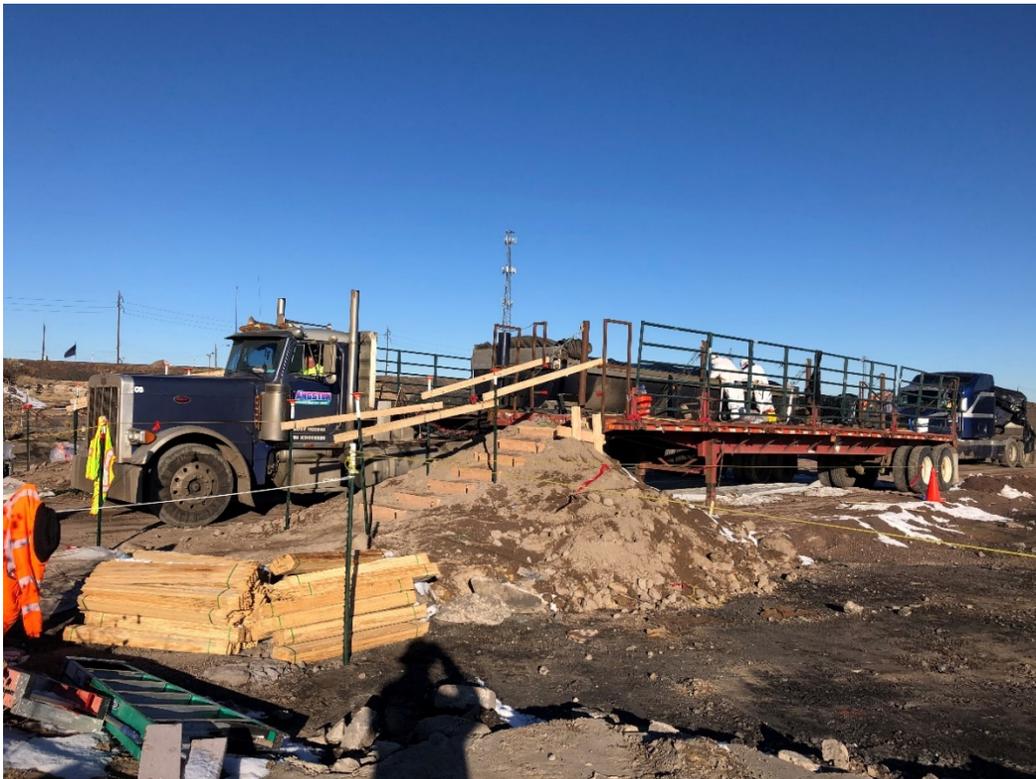
Figure 4: Wrapping Station

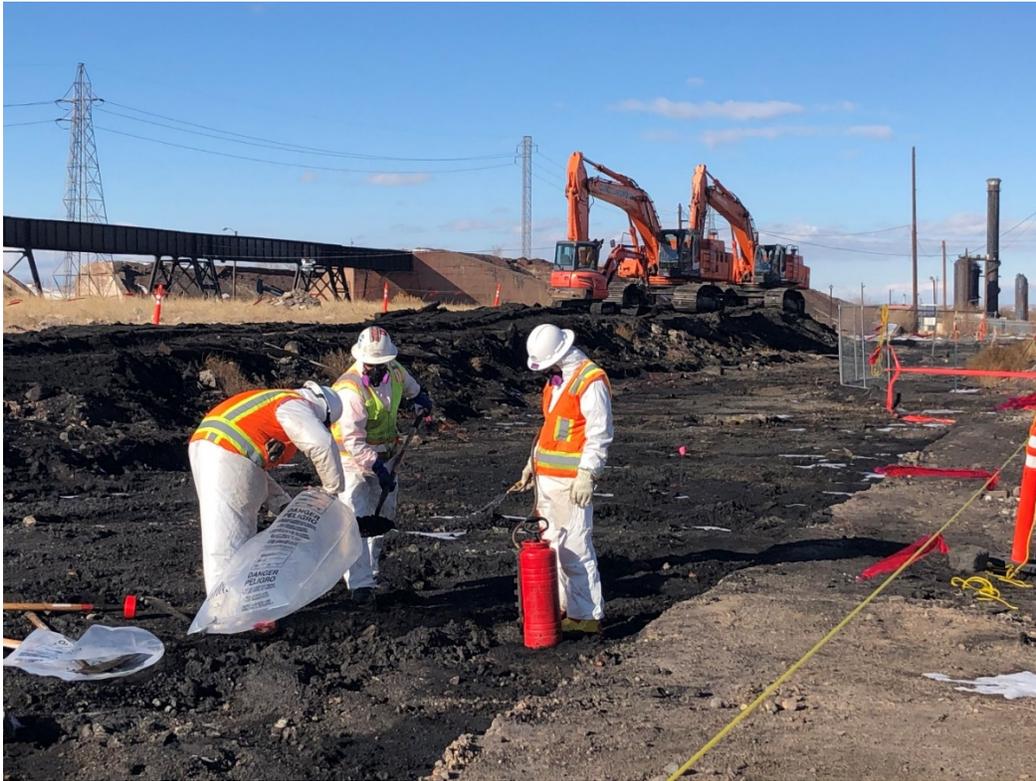
Figure 5: Workers Remove Asbestos Containing Materials in Limited Hand Removal Zones

The first step in the RACS remediation was to clear each grid of surface contamination, with each grid being inspected by the CABI. Pieces of suspected asbestos debris were marked and asbestos technicians went grid by grid to each spot identified by the CABI removing whatever object was identified as asbestos containing material as well as a foot of soil in all directions from where the object was located (Figure 5). The asbestos containing material was put in an asbestos disposal bag and transported to the landfill for disposal.

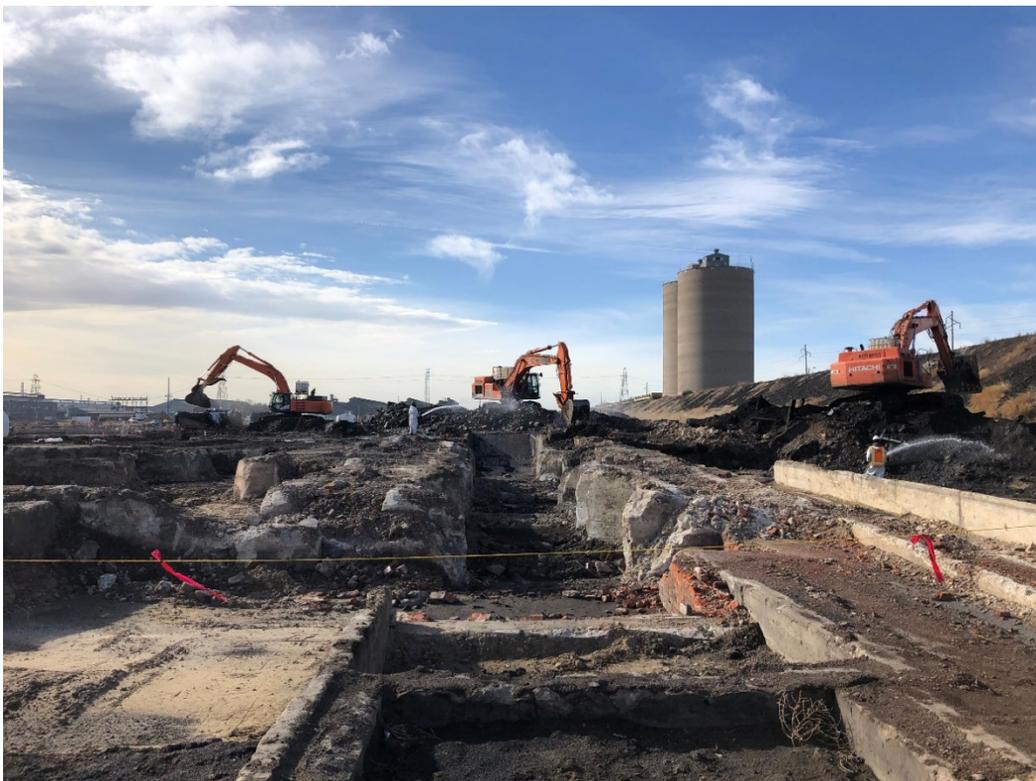
Figure 6: Dust Mitigation Techniques

During the first week of excavation, two separate perimeter air samples detected a single asbestos fiber. EVRAZ and CCC stopped all work to evaluate dust control. The entire area was covered with a magnesium chloride solution to suppress any potential asbestos fibers that may be released. CCC installed water tanks on each excavator. Mister bars were mounted to the excavator buckets, constantly spraying water during excavation. A worker at every active pile sprayed soils with a fire hose (Figure 6) Management rapidly designed a new monitoring plan with input from environmental consultants and CDPHE. Additional monitoring demonstrated no asbestos emissions during the remainder of the project.

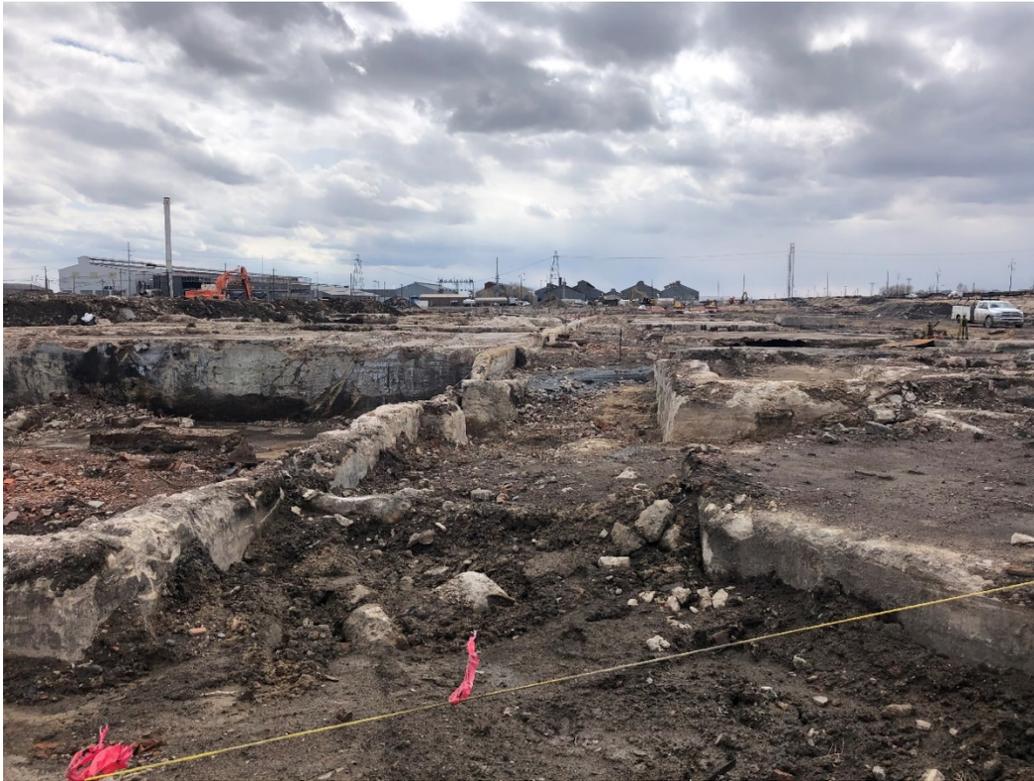
Figure 7: Exposed Foundation Elements to Remove

Once the contaminated soils were removed, concrete foundations were demolished (Figures 7 and 8) Concrete foundations were hauled to a different location to be processed and reused as structural fill. Before demobilizing from the site, all equipment required thorough decontamination. A leach pad was constructed in a contaminated area before the addition of the clean cap. Each piece of equipment was sprayed with firehoses and inspected by the CABI before it was permitted to leave the site.

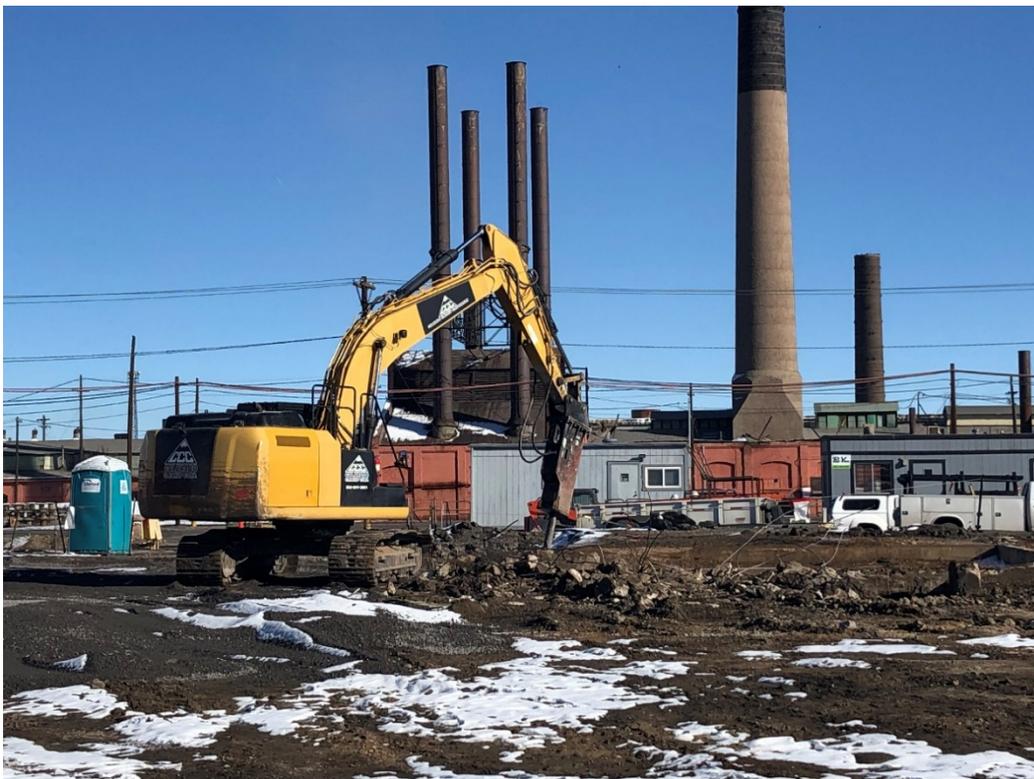
Figure 8: Removal of Foundation Elements
