AGC ACE Award 2016

Littleton Public School – Runyon Elementary Renovation

Runyon Elementary – a remodel that tops it all.

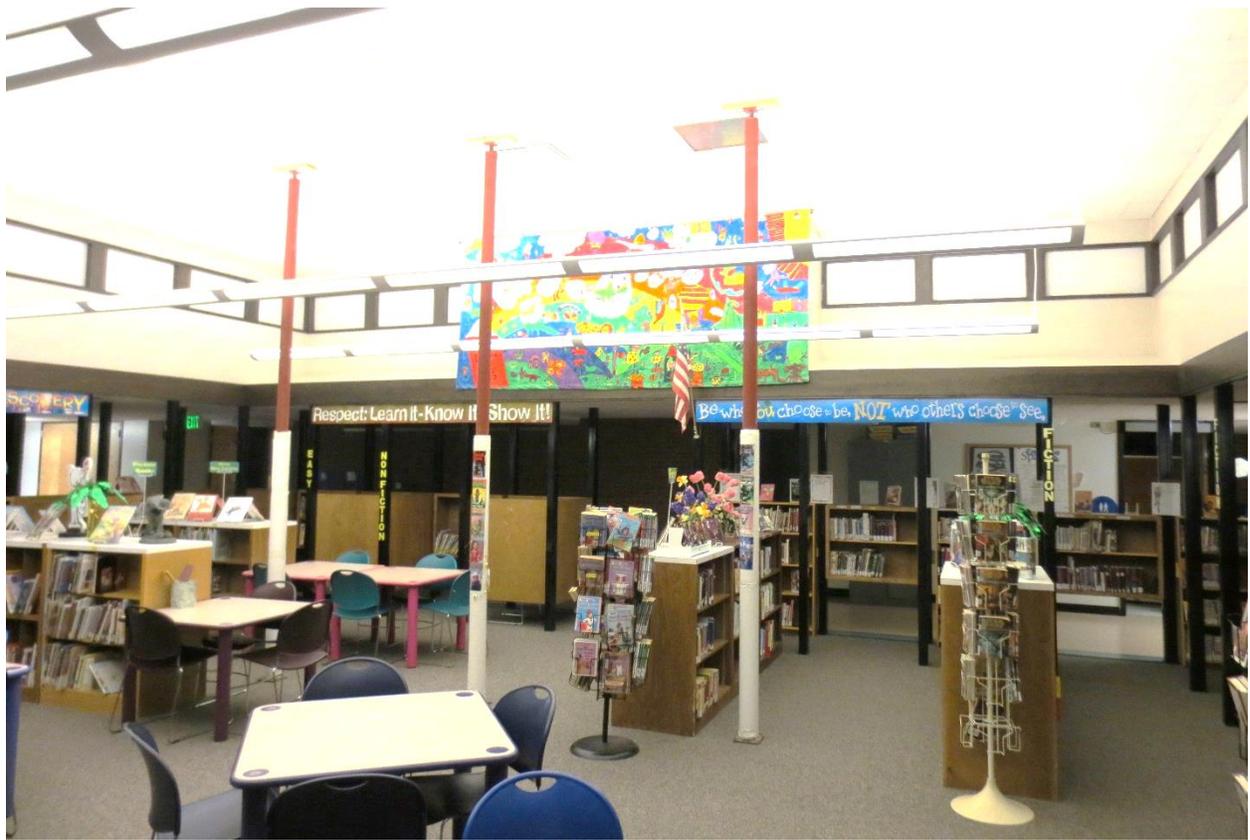
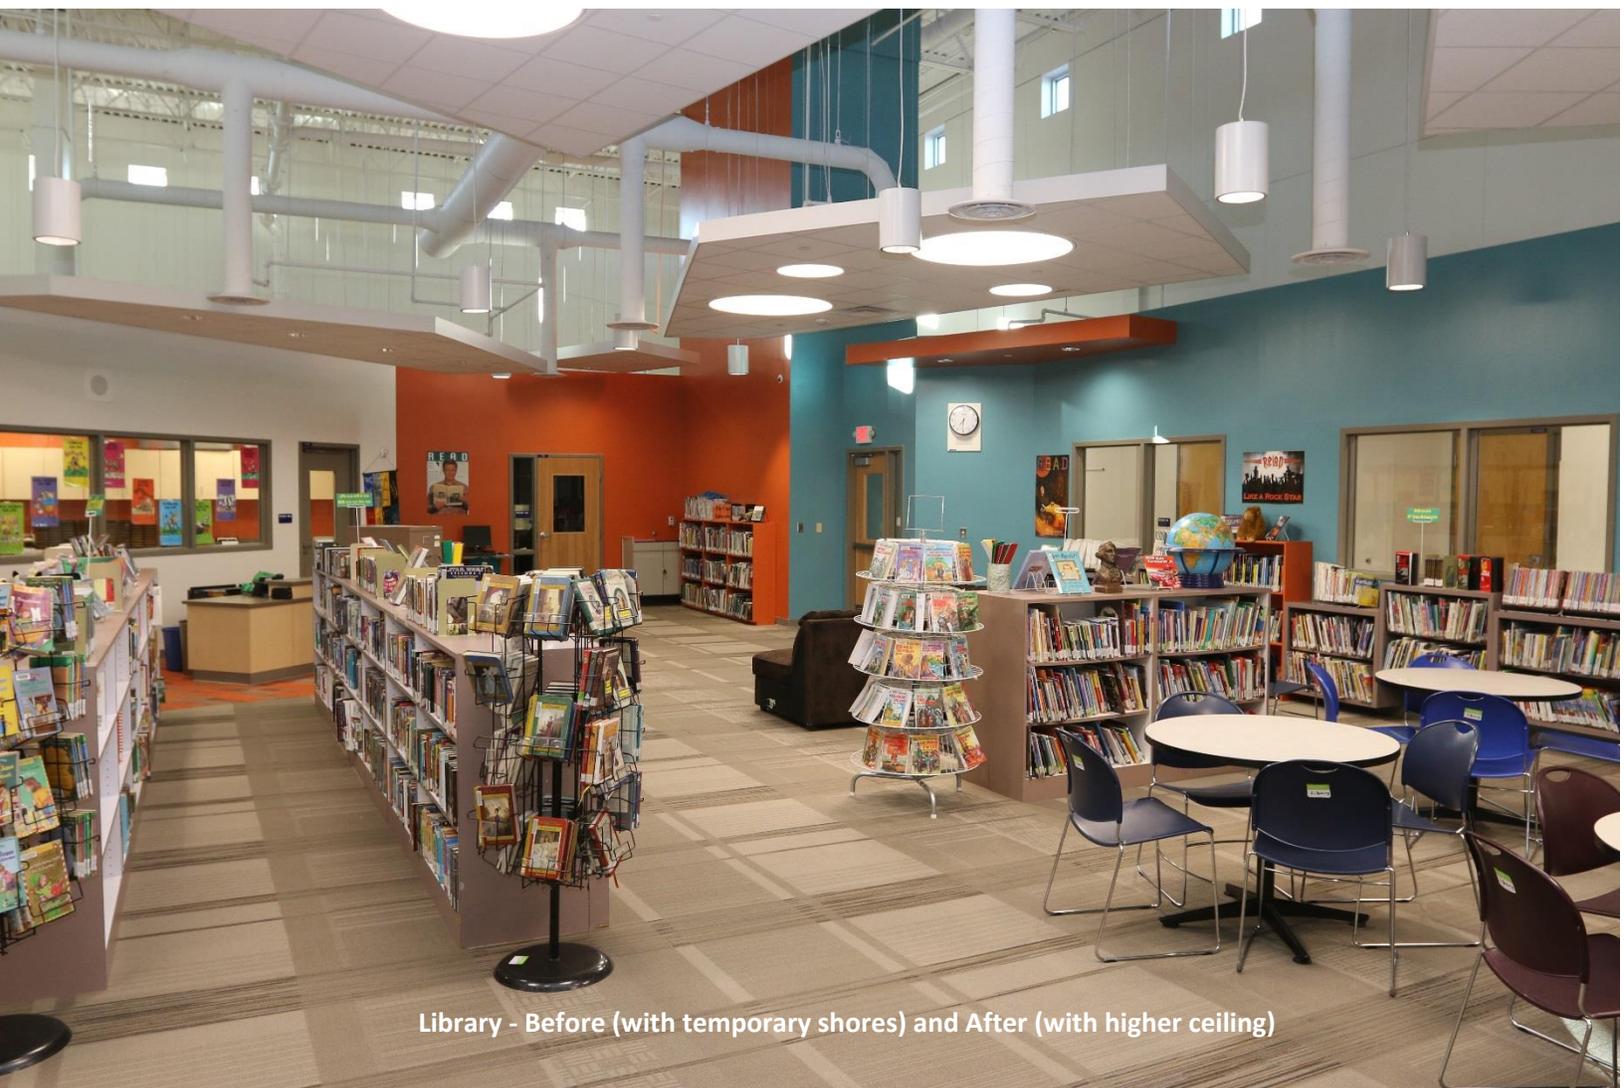
Library - Before (with temporary shores) and After (with higher ceiling)

The school quickly installed post shores throughout the building interior as a short-term fix. These temporary shores were almost always in the center of a room and not helpful to the learning environment. Listening to the community, a plan was devised that would keep as much of the existing building as possible while addressing a growing list of deficiencies. The necessary work included essentially removing the roof, raising virtually all the ceiling heights, replacing the entire HVAC and electrical systems, abating asbestos, and correcting many structural issues so the “existing” building would look like new when finished.

Many of the existing walls were extended to the higher ceiling heights. The tie between the wood structure and new metal studs above required special order of narrower metal studs to match the old wood materials. The new clerestories and skylights would bring light into the interior of the old building like never before.

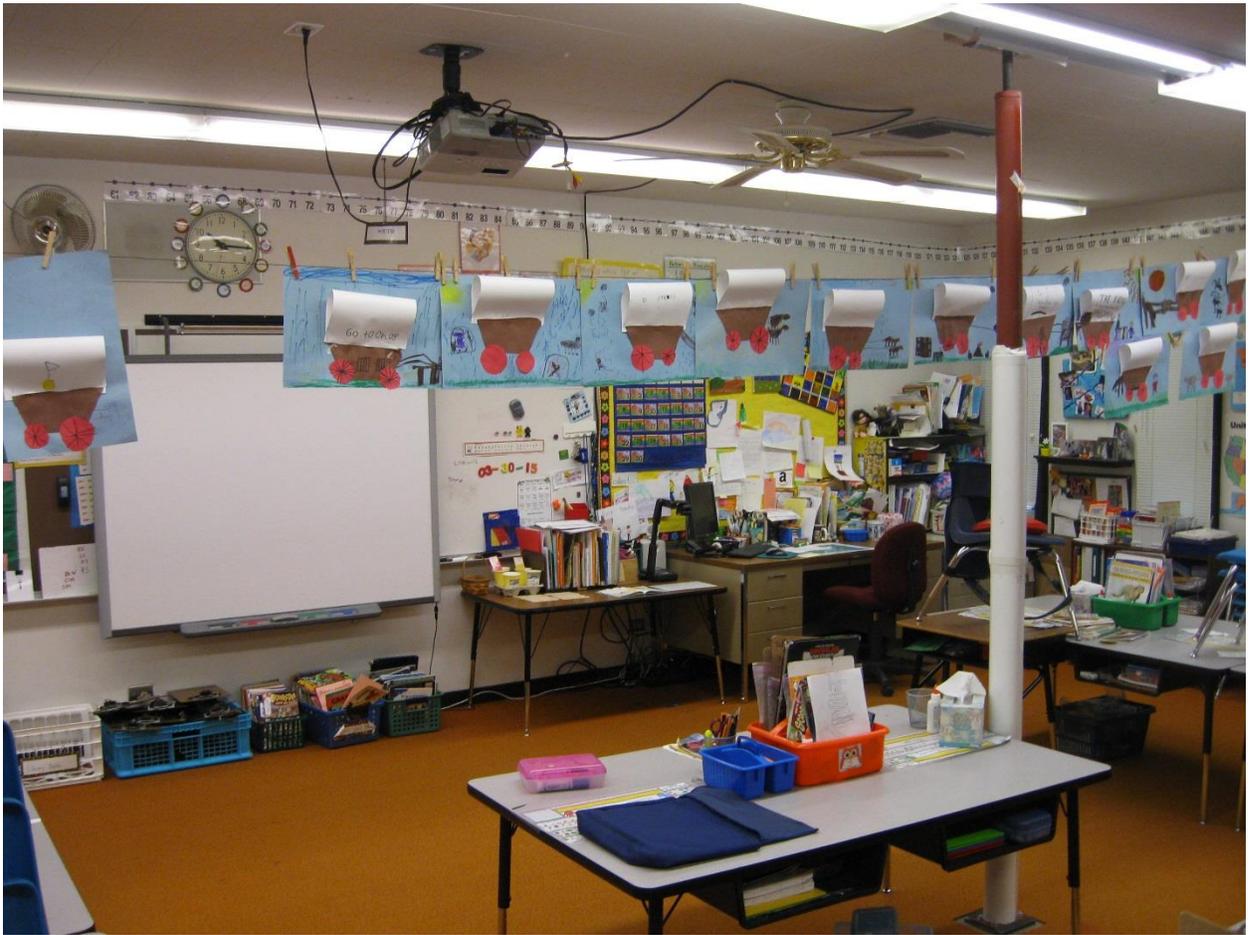
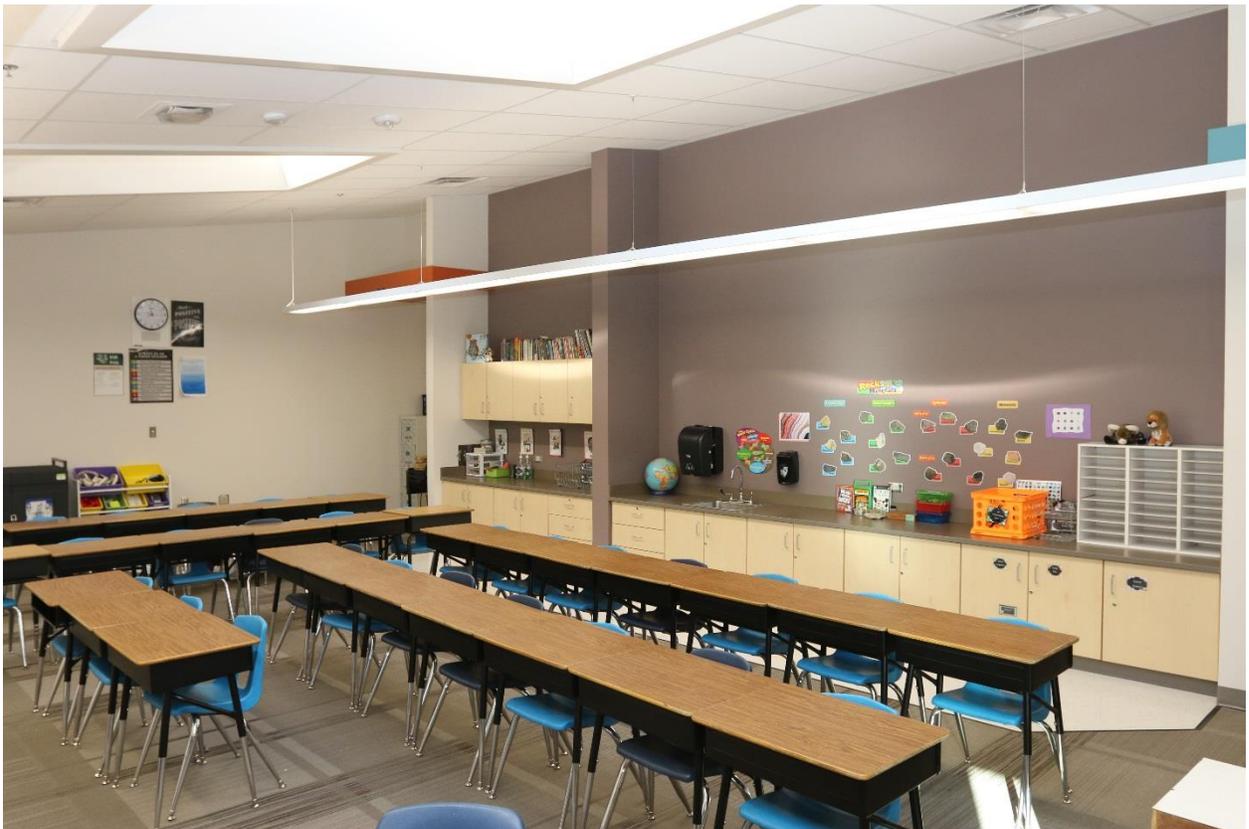
Typical Classroom - Before (with temporary shores) and After
